APRIL 2017

# Design Study Report

PEDESTRIAN BRIDGE INSPECTION  
MOA PROJECT B

Samantha Caldwell  
Shelley Giraldo, P.M.  
Jared Kinney  
Brian Weigand  
SEAWOLF ENGINEERING

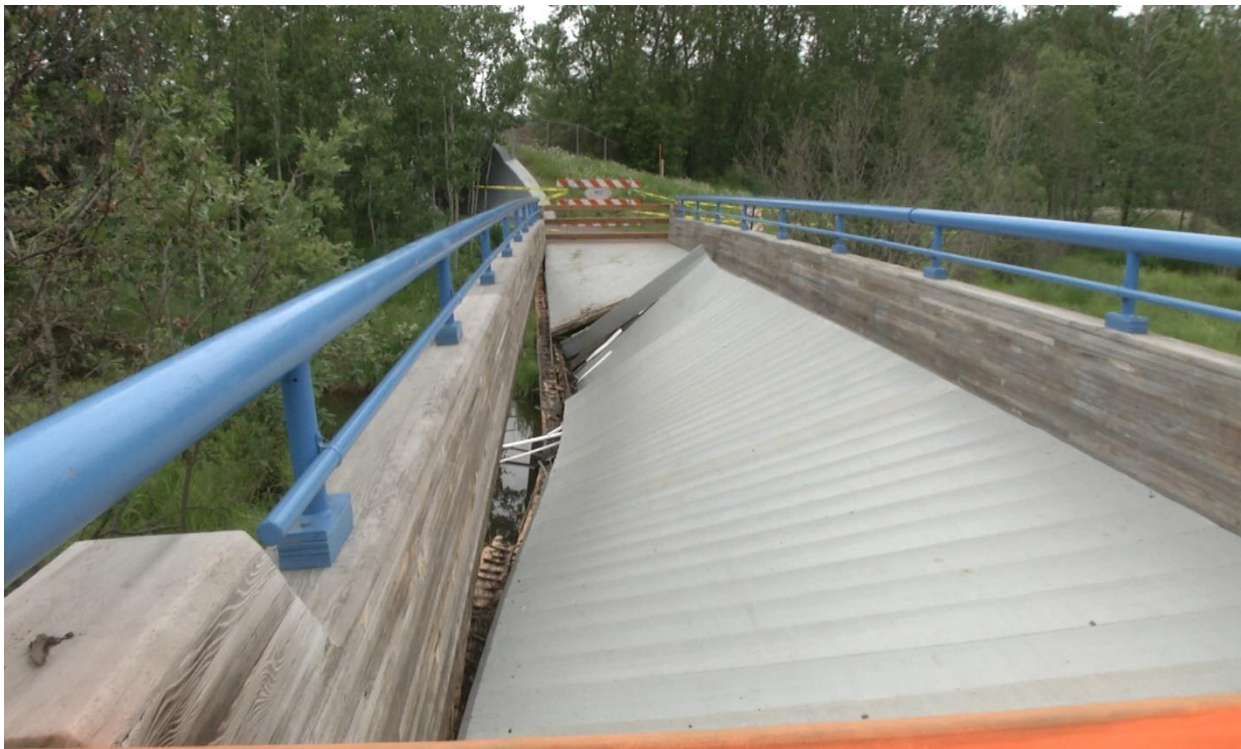
*Figure 2. Westchester Lagoon Bridge Failure*

The approximately 70-foot North Westchester Lagoon Bridge was built in 1987 to connect downtown Anchorage to Westchester Lagoon. The bridge was made from two glulam girders spanned by a wooden deck which was supported by wooden ledgers. On June 16, 2014, the bridge failed when a 7,099 lb. truck towing a 7,300 lb. wood chipper attempted to cross. USKH, Inc. conducted a failure investigation which determined that failure occurred due to cross-grain tension in the glulam beam. The failure stemmed from water draining off the deck and permeating the timber via lag bolts drilled into the glulam beam. The moisture caused decay leading to failure.

In 2013 the deck had been covered with a fiberglass overlay and the railings had been improved. However, no other retrofits or modifications had occurred since construction. Since MOA did not have a Pedestrian Bridge Inspection Program, the bridge had not undergone regular inspections to ensure that the design load ratings were still applicable. In 2015, the bridge was replaced by Bristol Prime Contractors.

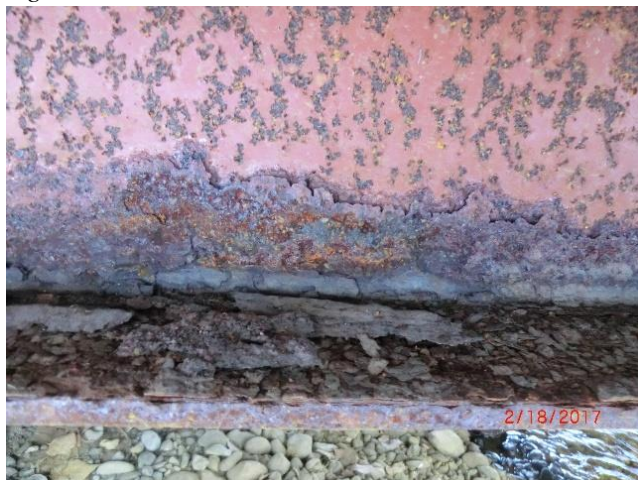
*Figure 3: Worst Corrosion on Girders*

The girders were found to be in fair shape, despite flaking rust, as depicted in Figure 3. Measurements, taken during site visits, confirmed that W10x33 beams were used, as called out in the original plan documents. A section loss analysis showed that section loss was insignificant. The analysis was performed by comparing the average dimensions of W10X33, provided by the American Institute of Steel Construction Steel Construction Manual 14<sup>th</sup> Edition (AISC SCM), with the measured dimensions of the Tikishla Park Bridge North. The percent differences found between the SCM average dimension and measured dimensions were very small and

only minor section loss was exhibited at various locations along the length of the beam.

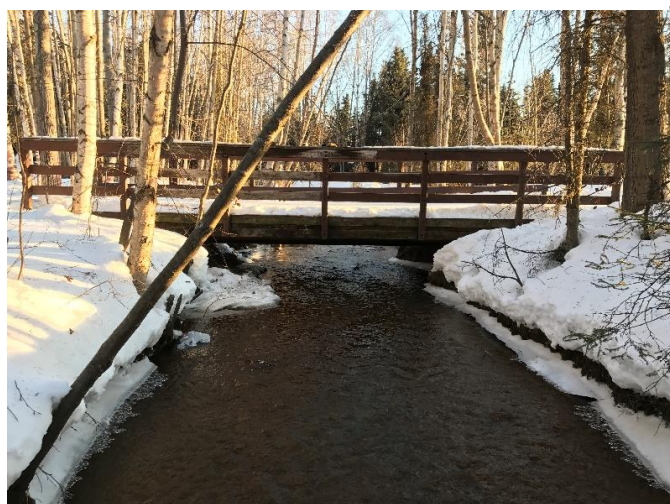
*Figure 4: Profile view of Sagging Bridge Frame*

When the waterway alignment from the plan sheets and the current waterway alignment were compared, it was determined that Chester Creek has meandered to the south. The creek has begun to encroach upon the southern abutment of Tikishla Park Bridge North. Possible settlement was noted in the inspection report at the southern abutment. The frame and railing were visibly sagging, as portrayed in Figure 4. It is possible that erosion of the Type II classified fill, combined with high moisture content and poor native soil properties, contributed to the settlement. A more thorough geotechnical investigation would need to be conducted for confirmation.

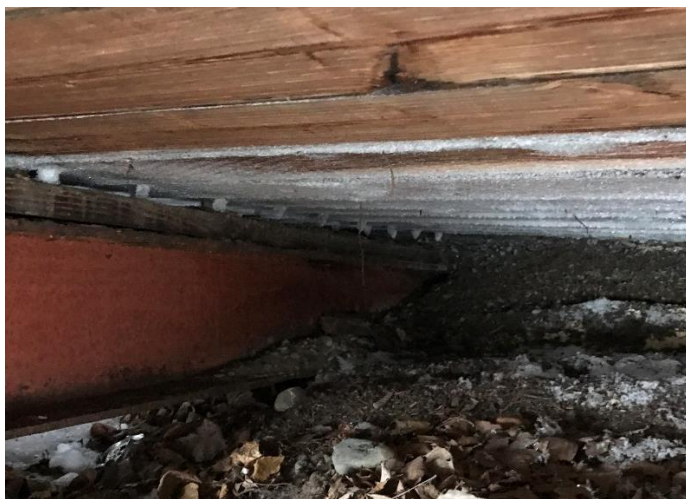
Figure 5. Frame and Girder Separation

At the south end of the bridge, the 2x8 spacer and girder were separating from the decking (shown in Figure 5), which could be due to settlement. The length of the separation is approximately 4' long and 1" wide, and in this area the (2) 3 1/2" lag screws were stripped from the 2x8 spacer. Debris accumulation at the end of the girder prevents contact between the timber frame and the girder year round. The gap was assumed to be insignificant for the analysis because large loading, such as a H 5 design vehicle, would likely cause the frame to deflect and come into contact with the girders.
