GROUP B – PEDESTRIAN BRIDGE INSPECTION PROJECT Final Presentation

Samantha Caldwell
Shelley Giraldo
Jared Kinney
Brian Weigand

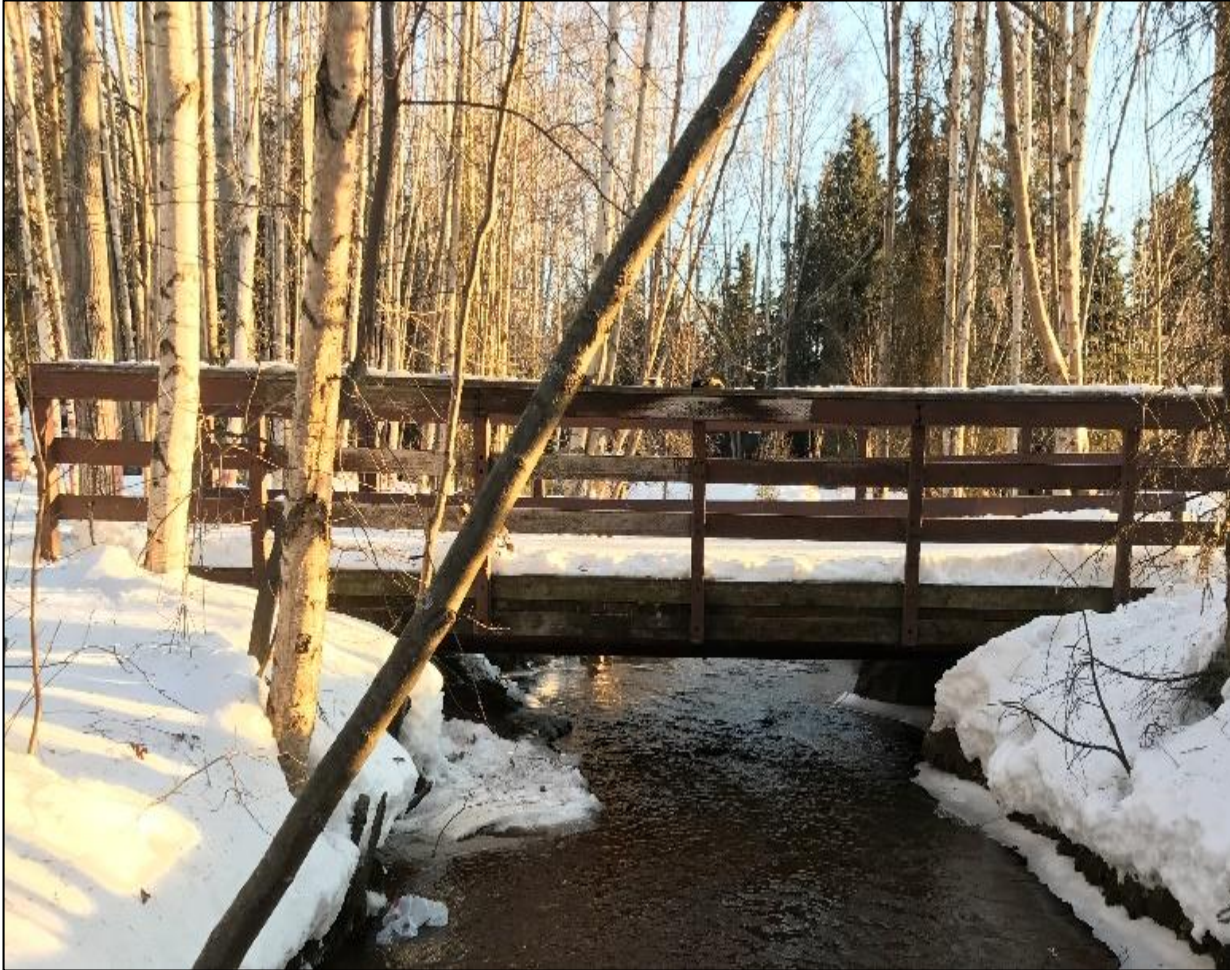
- ▶ Tikishla Park Bridge North
- ▶ Spans 28.5' X 9' Wide
- ▶ Limited Sight Distance
- ▶ Wooden Railing and Deck
- ▶ Supported by (2) W10x33 beams

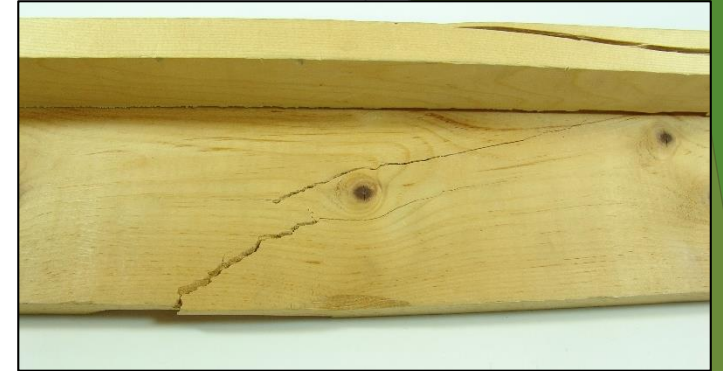
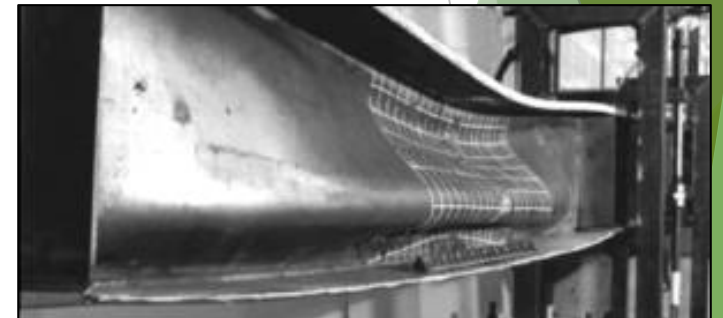
- ▶ Timber Decking
 - ▶ L+D+S: did not fail
 - ▶ D+L: failed due to shear
- ▶ Steel Girders
 - ▶ L+D+S: failed in bending (and deflection)
 - ▶ Pedestrian Load: 152 people (not likely)
 - ▶ D+L: did not fail (excessive deflection)
