# CE A438 Design of Civil Engineering Systems

## Forest Park Condominiums

***Tectonic Engineering:***

# PROJECT SUMMARY

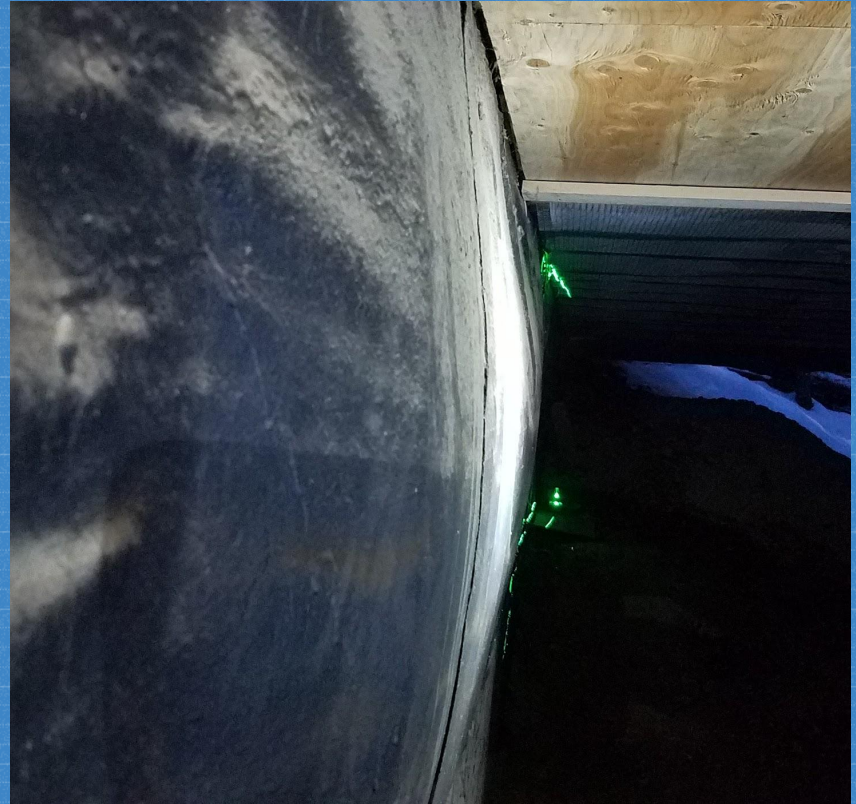
Blown out garage  
foundation wall

Deflection

Lack of soil  
backfill

Garage wall sheathing  
Foundation wall backfill

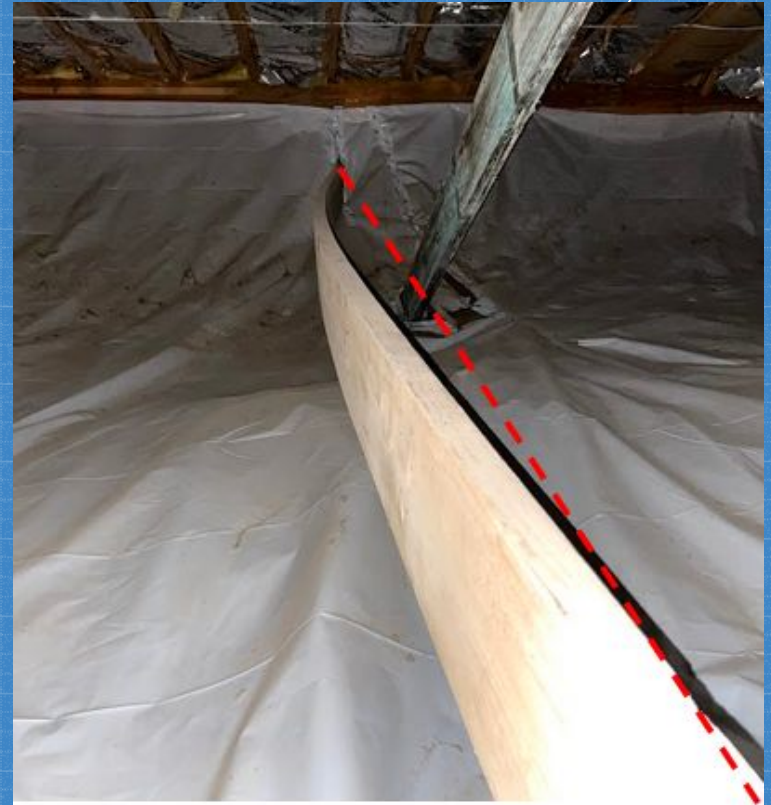
Inspected crawl space

Lateral bracing  
deformation

Unsupported braces

Unconventional  
building techniques

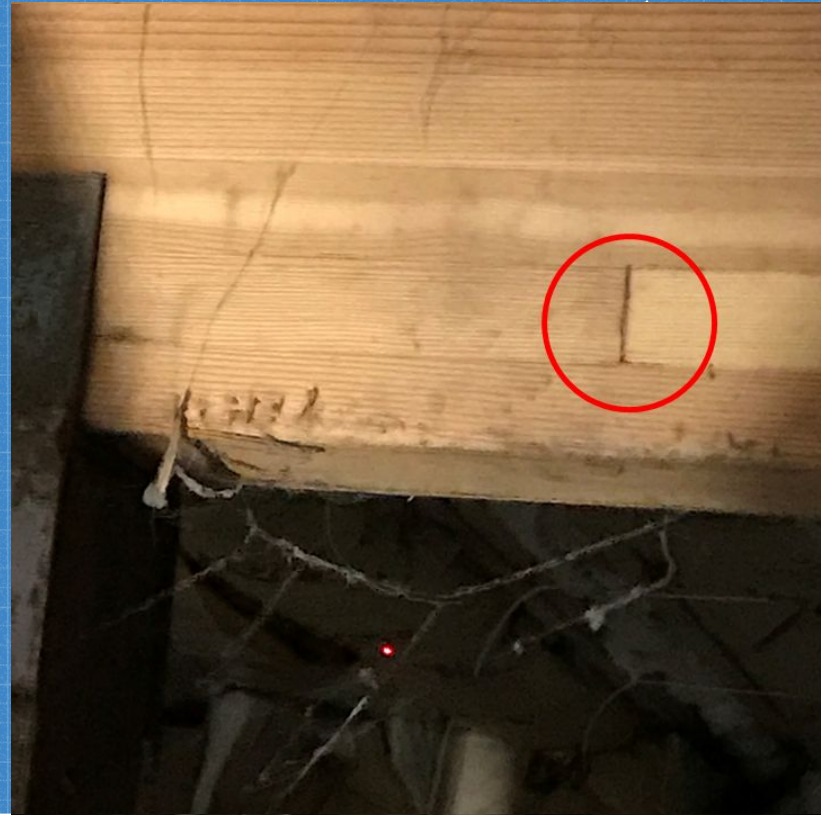
Glulam beams  
supporting floor  
joists

Lack of finger  
jointing

Porch Columns  
Garage Trusses  
Glulam Beam

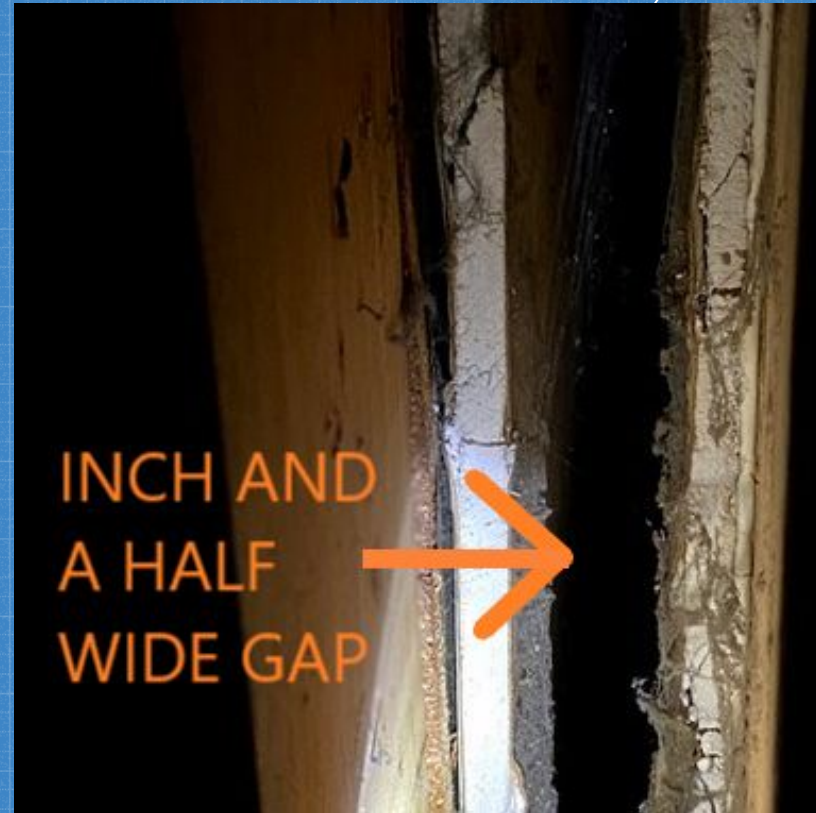
Lack of shear strength

Crawl space walls

Piling foundation

Relief joint

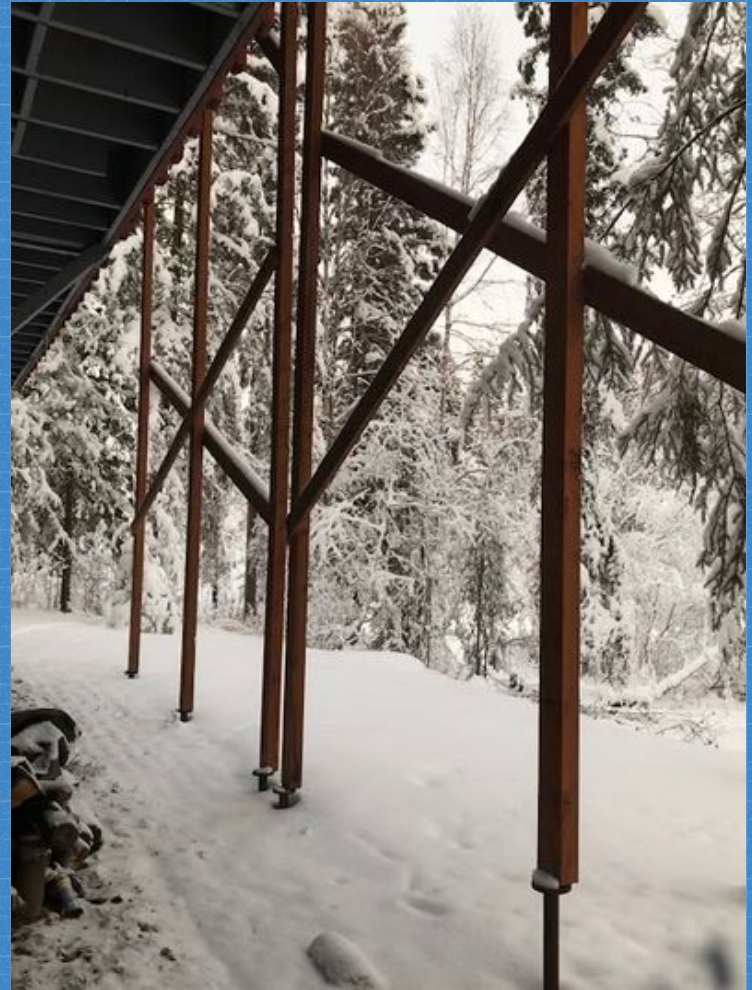
Slender porch  
columns

Possibility of  
buckling

Foundation

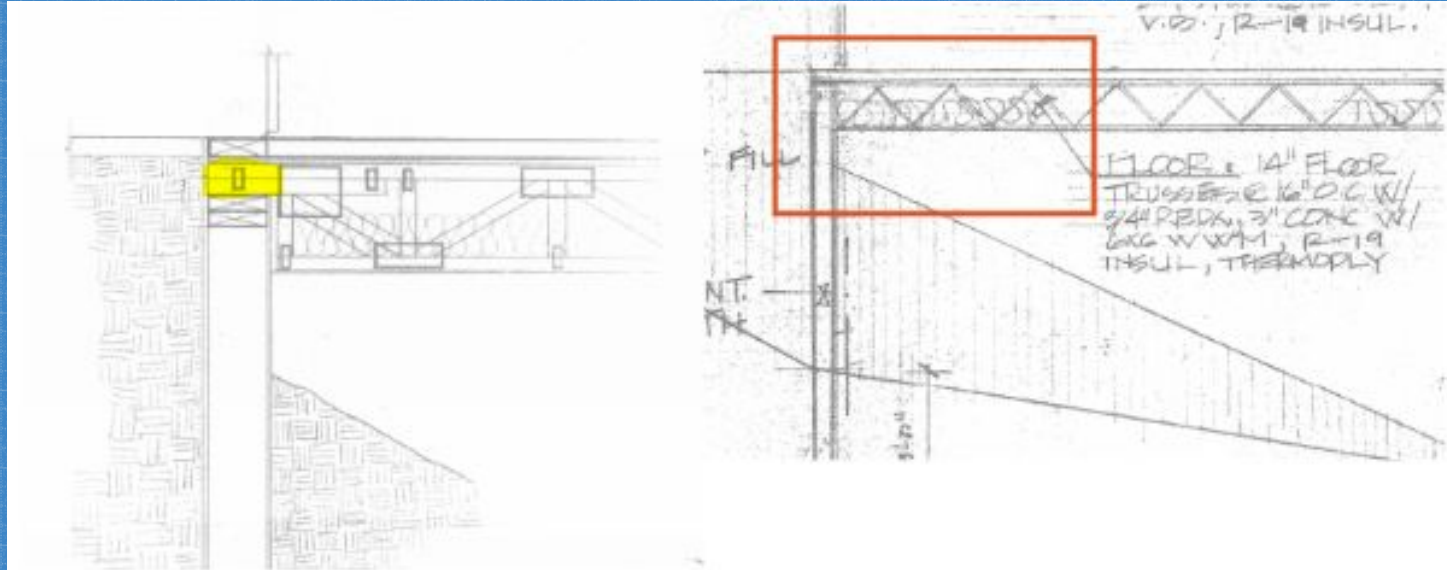
Garage floor truss

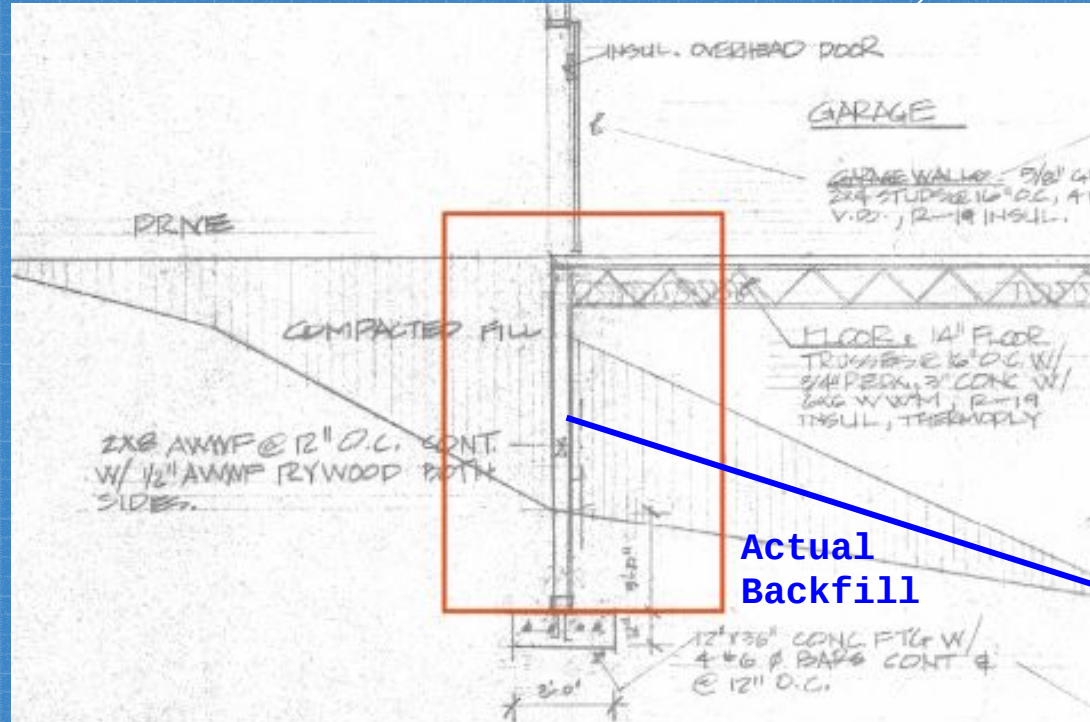
Lack of backfill  
in foundation  
wall

Potential cause  
of deformation

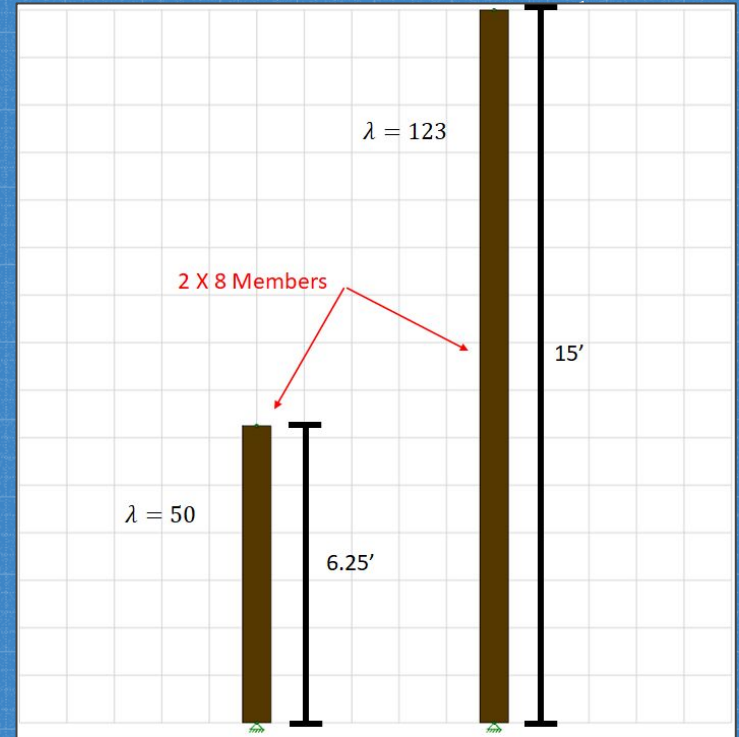
- Very slender
- Only braced at ends
- Cannot utilize member for compression
- Not ductile

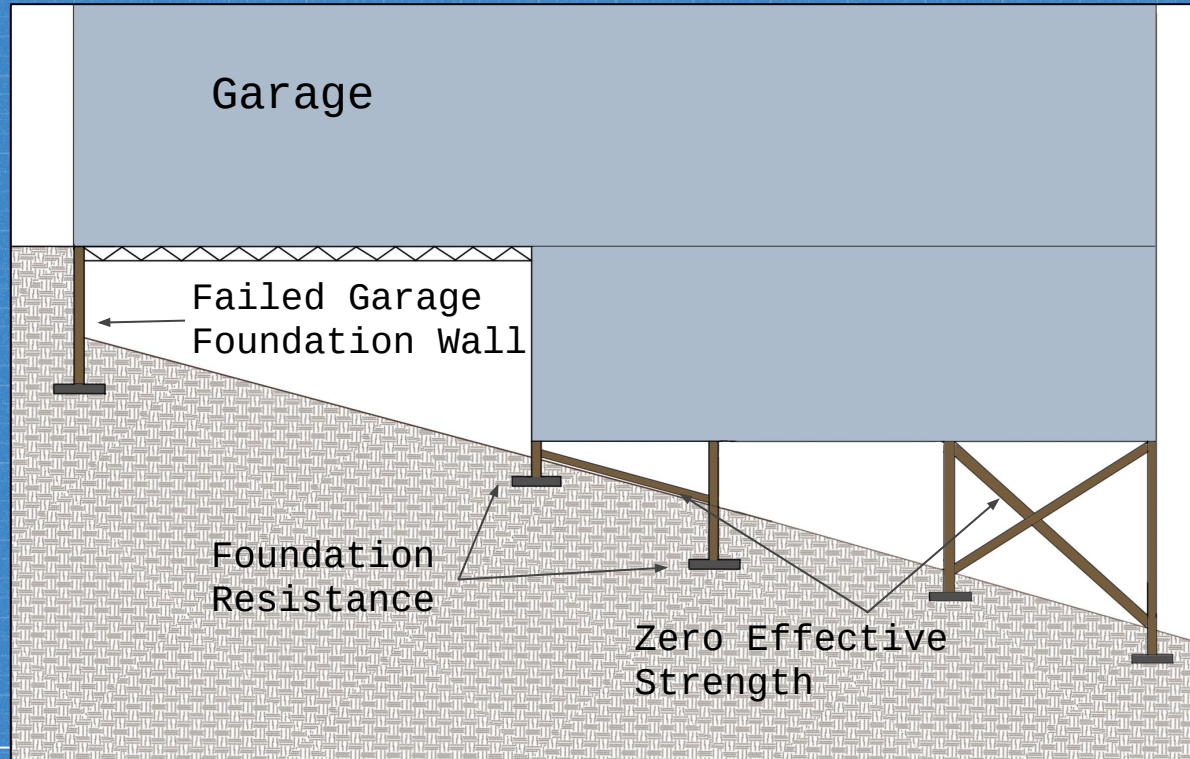
Failed Garage  
Foundation Wall

Shear resistance for  
the crawl space

Shear resistance  
through the  
foundation
