EXPERIMENTAL TESTING AND SEISMIC PERFORMANCE ASSESSMENT OF WOOD-FRAME SHEAR WALLS WITH COMMON CONSTRUCTION DEFECTS

FINAL PROJECT REPORT

for
Federal Emergency Management Agency (FEMA)
CTP Program

January 13, 2025

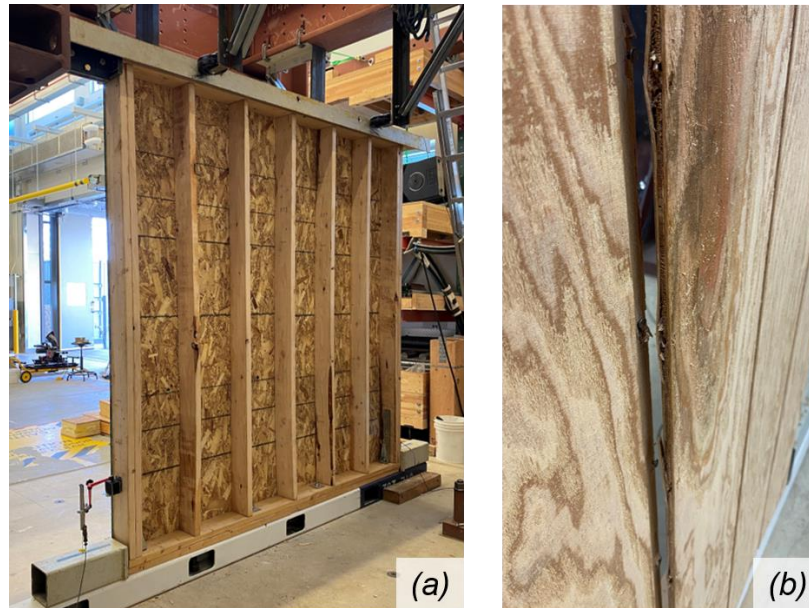
Fig. 7. (a) test wall with OSB sheathing (b) Post-test T1-11 seam with single row of nails.

Inspectors noted that T1-11 siding was frequently improperly attached along the seams between two panels. Instead of a row of nails at the edge of each panel into the stud as specified by the IRC and IBC, a single row of nails is often placed in the small area where the panels overlap. We replicated this deficiency in two locations in the 8 ft x 8 ft wall assembly by modifying the panels into a (2 ft)-(4 ft)-(2 ft) configuration, which allowed the center panel to have this condition along both vertical edges. These tests are described as “double row” or “single row” to indicate the placement of nails at the seams. Fig. 7b shows the seam between T1-11 panels with a single row of nails at the end of the cyclic loading protocol. Panel thickness at the seam is half the full thickness to accommodate a lap joint. This thinner section is more susceptible to failure under lateral loads.

- Building codes should be enforced through plan review and onsite construction inspections
- T1-11 laps should be double nailed, and inspectors should pay particular attention to this during construction.
- Additional nails should be added in shearwalls in houses suspected of having inadequate length of shear walls or a low number of fasteners.
- Houses should be inspected to ensure adequate hold-downs
- Despite being stronger but less ductile in testing, modeling indicates that staples provide the same level of collapse prevention. However, given the choice, we recommend nails.

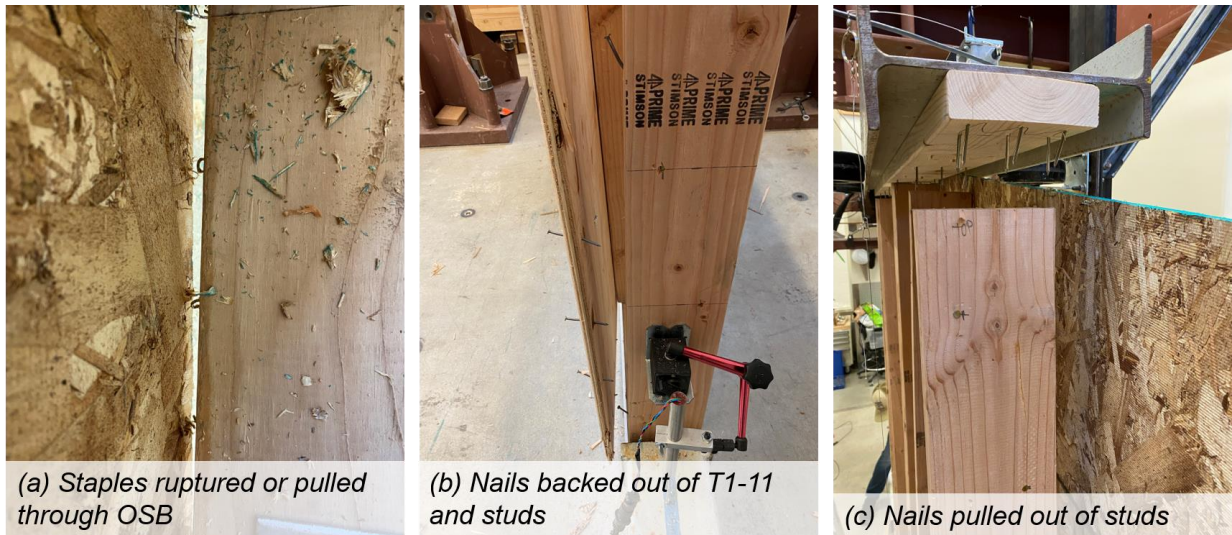
In many cases, failure occurred at the top or bottom plate of the wall assembly. In this failure mode, the nails at the top or bottom edge of the panel backed out or ruptured and then the end nails connecting the top plate to the studs withdrew under the increasing cyclic load. This failure also sometimes occurred at the bottom edge of the wall assembly.

Fig. 9. Failure mechanisms in wood-frame wall assemblies.

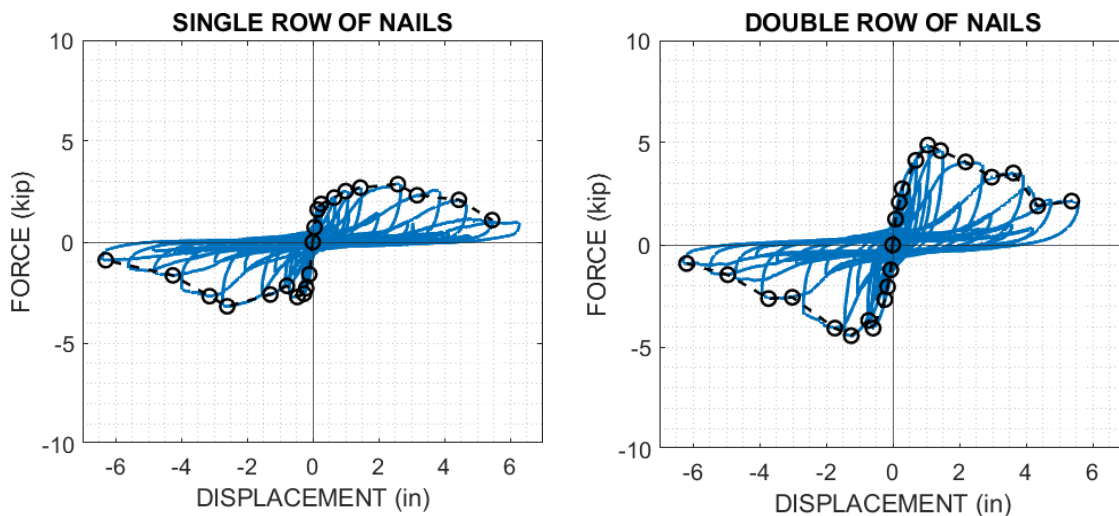
When a single row of nails is placed at the edge of a T1-11 panel, the panel and nails separate at low levels of displacement and force, which leads to rupture of the narrow edge of the panel. **Fig. 10** shows the difference in strength provided by an additional row of nails. The double row of nails is roughly equal to the strength of the baseline wall (4.9 kips, or 91%), the single row of nails is held only 3.6 kips, or 66% of the baseline. While the wall assembly with a single row of nails is more ductile, it is likely to lead to more damage at lower shaking intensities than houses with nails correctly placed. It is recommended to mitigate this condition by adding a second row of nails. Since T1-11 is often used as both sheathing and siding, it is typically exposed and not difficult to inspect and retrofit.

Fig. 10. Wall assemblies with single and double rows of nails at edge of T1-11 panels.

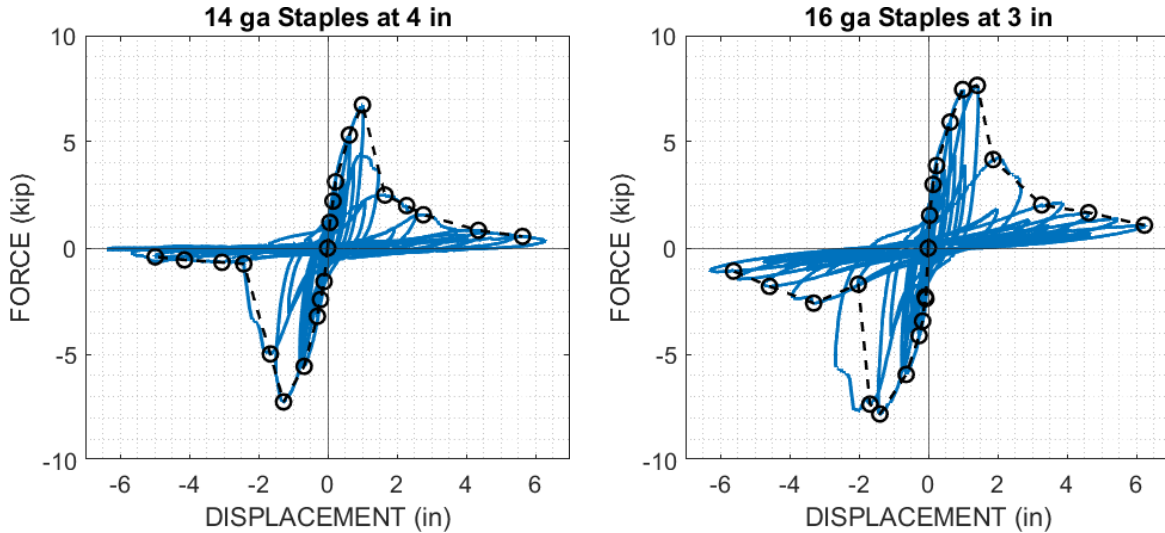
Fig. 11. Hysteretic response of walls staples. with (a) 14-ga staples spaced at 4 inches on center and (b) 16-ga staples spaced at 3 inches on center.

Both configurations are relatively strong (146% and 131% of the baseline configuration, respectively) and experience brittle failure. The ductility of the walls with staples were only 56% and 29% of the ductility of the baseline configuration.

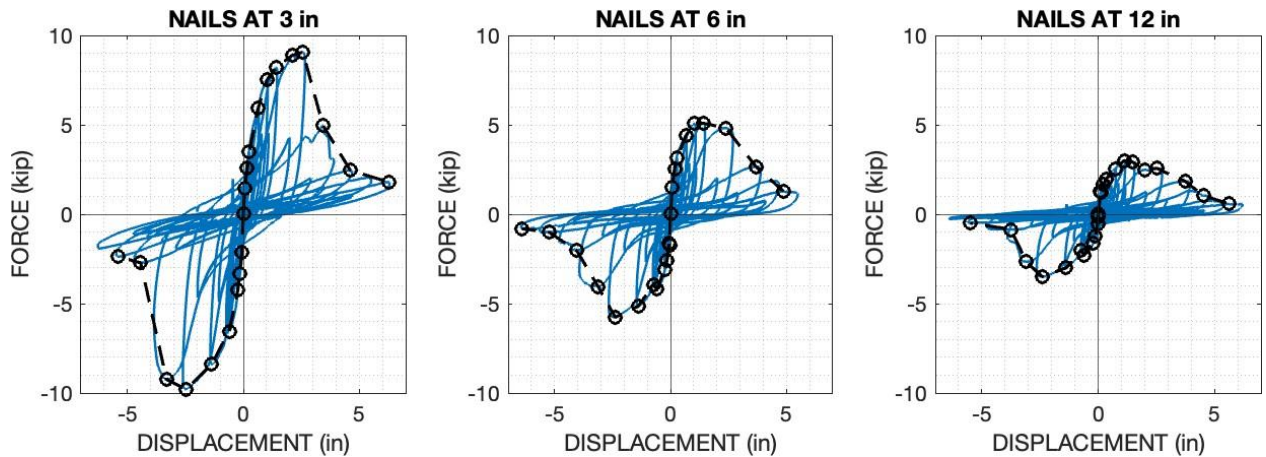
Nail spacing, and the resulting quantity of driven nails resisting loads, had the largest effect on wall strength and ductility. Fig. 12 shows the hysteretic response of walls with $2\frac{1}{2} \times 0.131$ -in nails with 3, 6 and 12-in. edge spacing. The walls have large variation in peak strengths, exhibiting a nearly linear relationship between nail spacing and strength. As spacing increases, ductility also increases (again almost linearly), while stiffness remains relatively constant (Table 2). The 3-inch spacing had 166% of the strength of the baseline configuration (6-inch spacing), while the 12-inch spacing had only 64% of the strength of the baseline configuration. Meanwhile, the 3-inch spacing had only 44% of the ductility of the baseline wall, while the 12-inch spacing had 128% of the baseline ductility.

Of note, the 2021 SPDWS (ANSI/AWC 2021) indicates that the 3-inch spacing has a design strength that is 187% of strength of these walls with 6-inch spacing, which is more than the 166% revealed in the testing.

Fig. 12. Hysteretic response of walls with varied nail spacing.
