Twenty Mile Bridge

(Project E)

April 21, 2017

CE A438 Senior Design

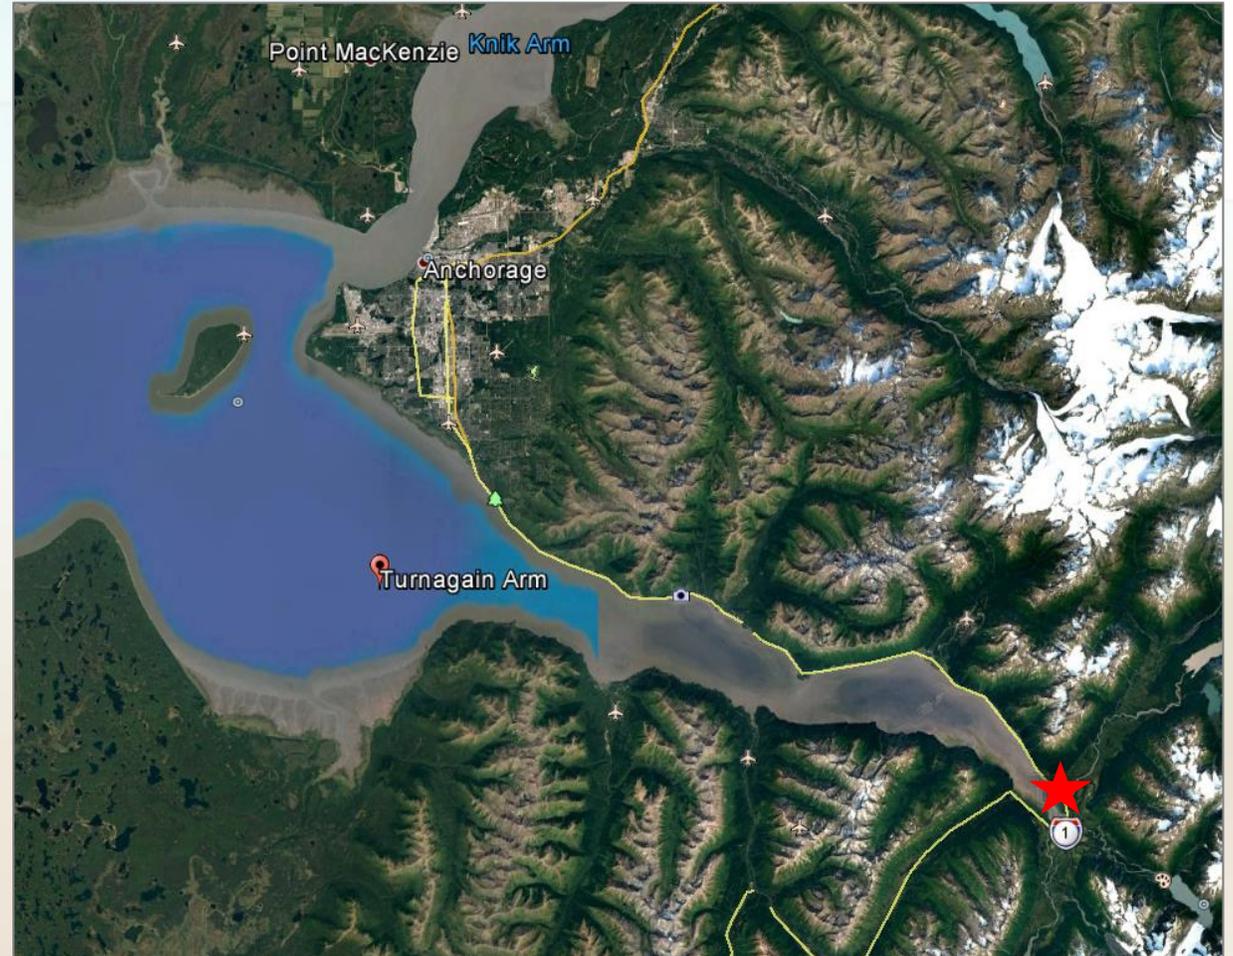
- Client: Alaska Dept. of Transportation & Public Facilities
- MP 80 of Seward Highway
- Constructed in 1967
- Previous bridge destroyed in the 1964 earthquake

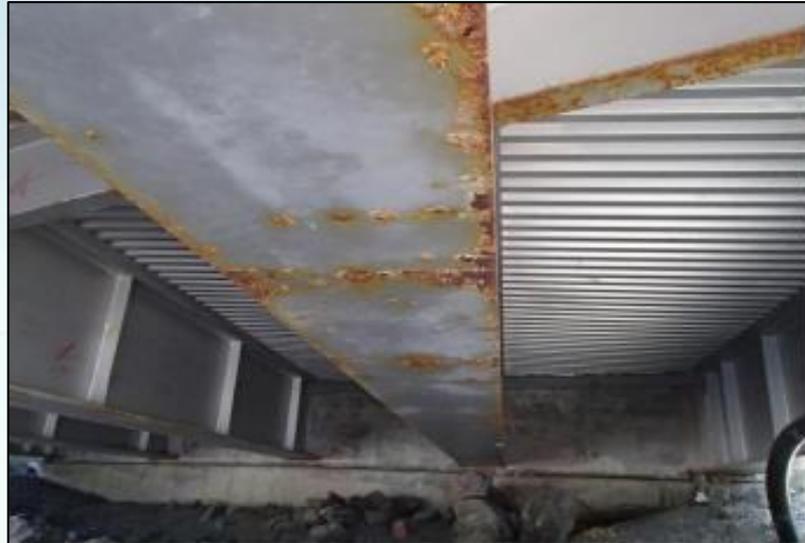
Bridge No.	0634	Br. Name	Twenty Mile River	Date	06/16/15
Tab No.	1	Inspector	Imbsen / Manning	Frame	35
Bottom Flange Rust, Typical

- Structurally deficient bridge
- Exposed rebar
- Pier walls cracked
- Decking in poor condition
- Diminished load rating

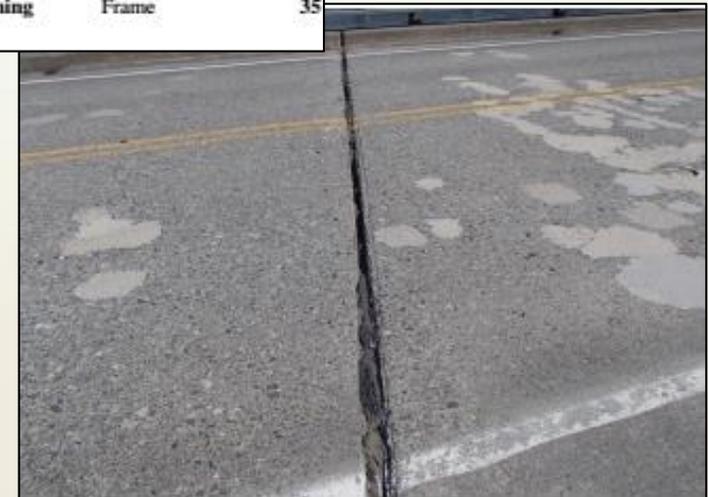
Bridge No.	0634	Br. Name	Twenty Mile River	Date	06/16/15
Tab No.	1	Inspector	Imbsen / Manning	Frame	
Pier 5 Joint Material Failed

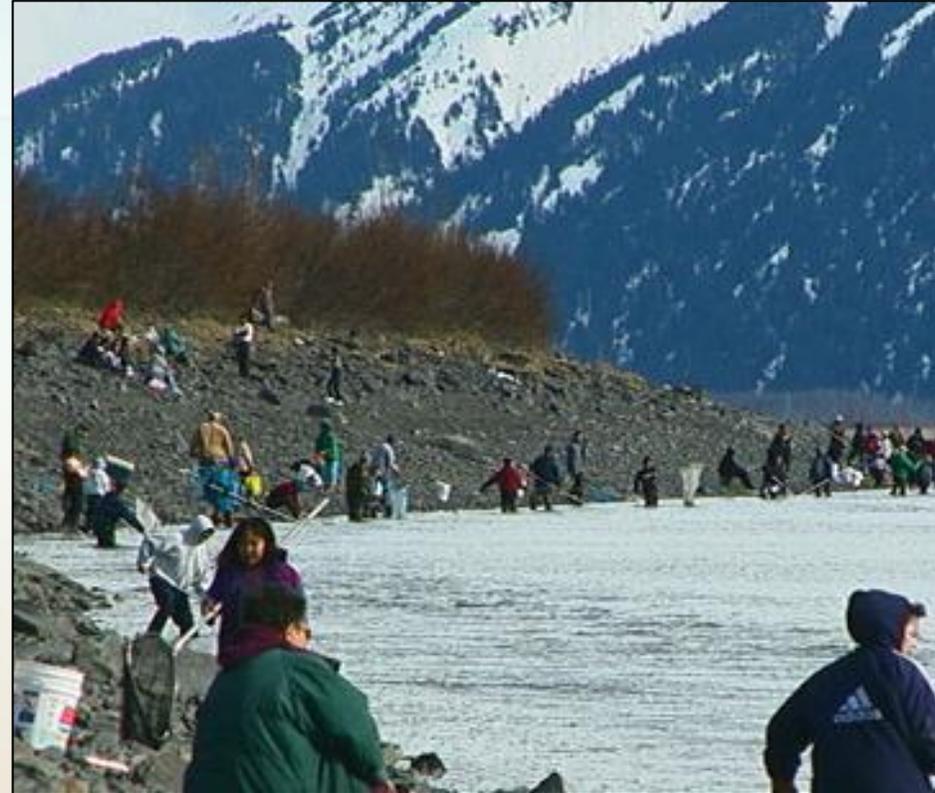
- Competing uses of corridor result in safety concerns
- Highest in summertime due to fishing
- Major injury and fatality crashes

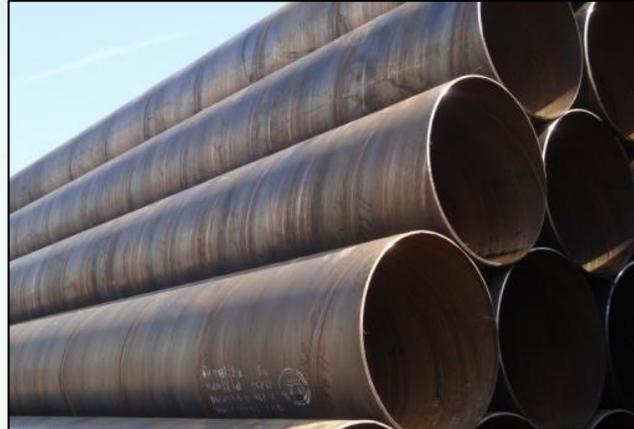
- Subsurface exploration
 - Soil strength parameters
 - Bearing capacities
- Liquefaction potential
 - Simplifying assumption: bedrock at 130 feet
- Steel pipe piles (API-5L)
 - No H-piles used
- Pavement Structure

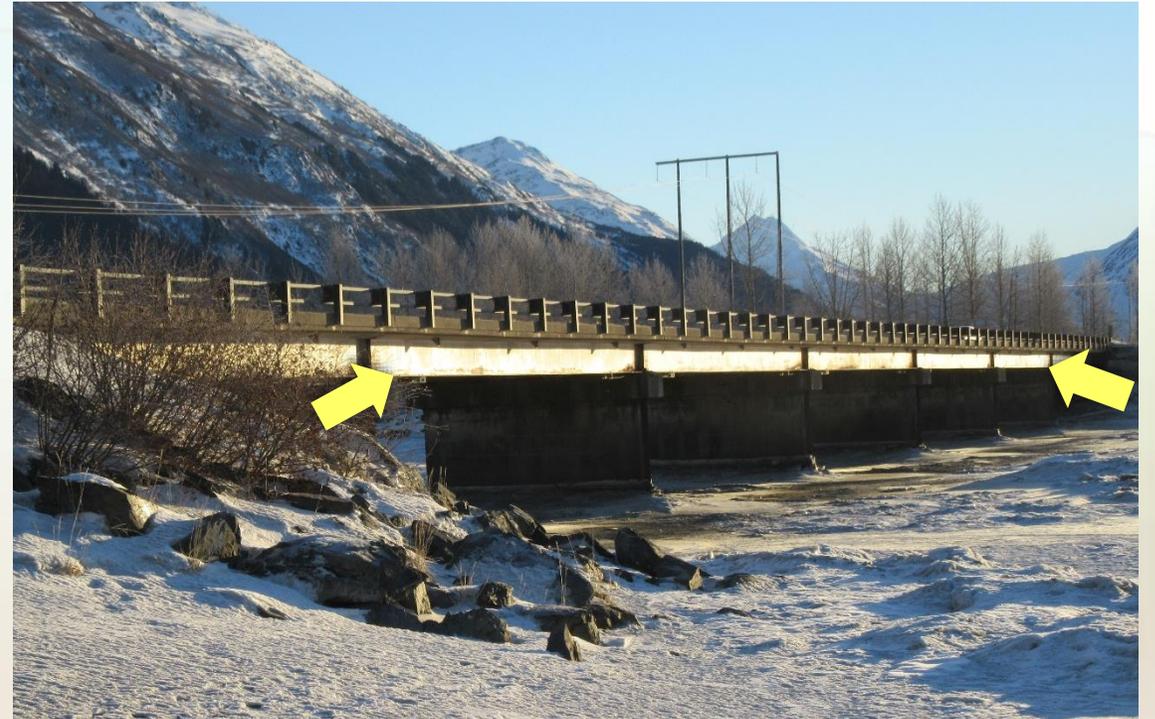
- Mean High Water (MHW): 22.0'
- 100-yr flood: 21,500 cfs
- High Tide Line (HTL): 30'; low-chord on south side: 33'
- Shared use path under bridge: 25'; low-chord on north side: 35'

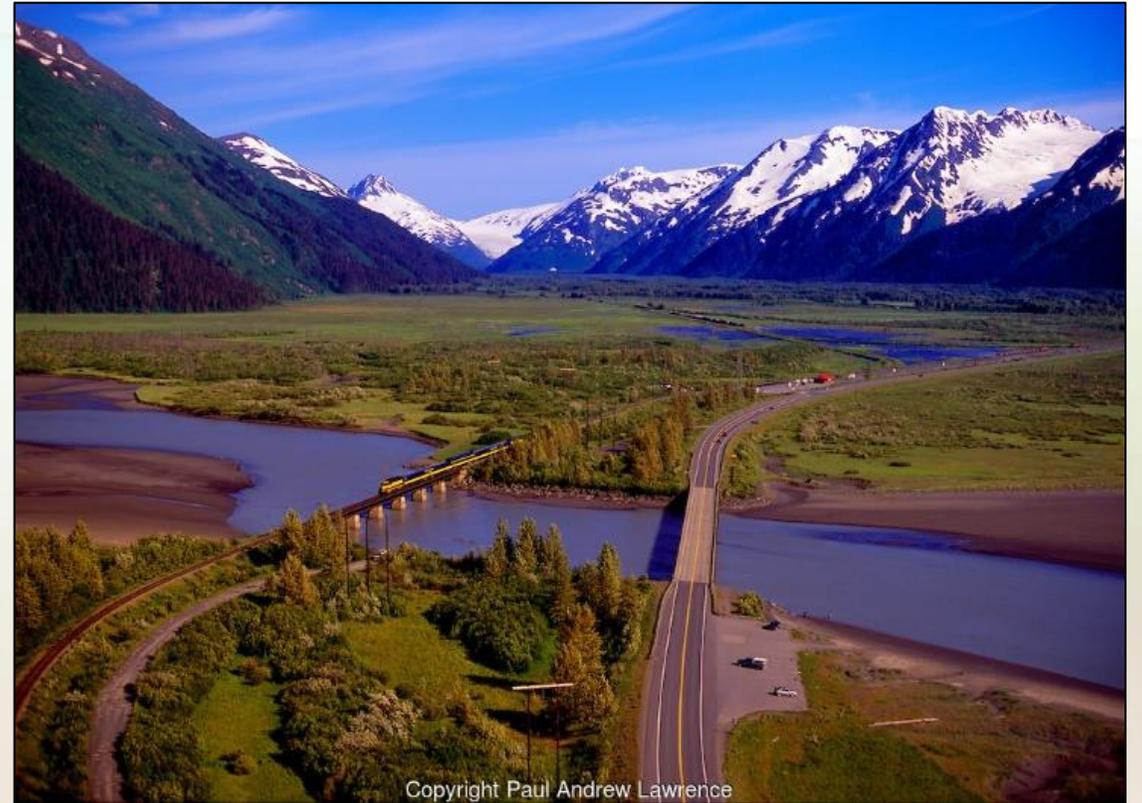
- Design speed – 65 m.p.h.
- Design year ADT – 7930 veh/day
- Minimum curve radius – 1660'
- Design K value – 193
- 12' lanes, 8' shoulders, 2% cross-slope
 - 10' shared use path on bridge

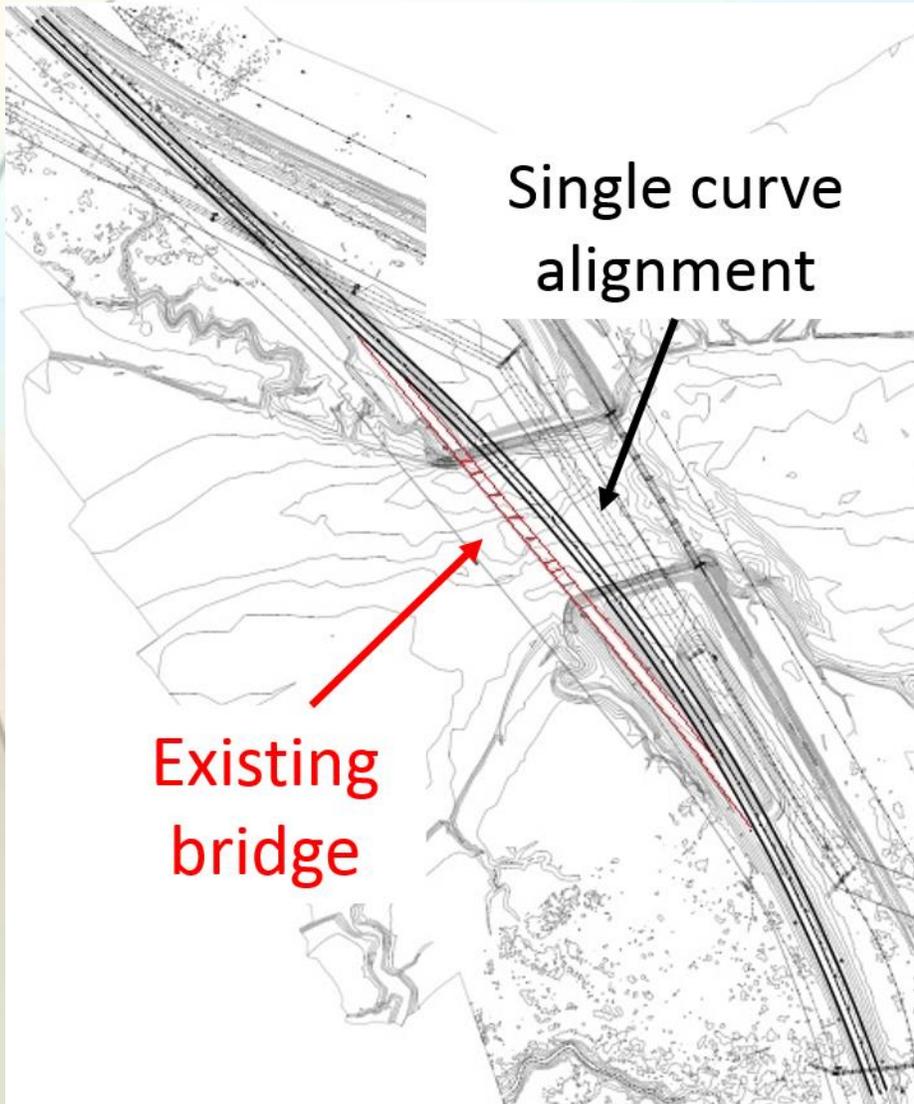
Preferred Alternative: Alignment

- East of existing bridge
- Single Horizontal Curve
 - 4900' radius
 - 3.2% superelevation
- Crest vertical curve north of bridge
 - Provides bridge drainage

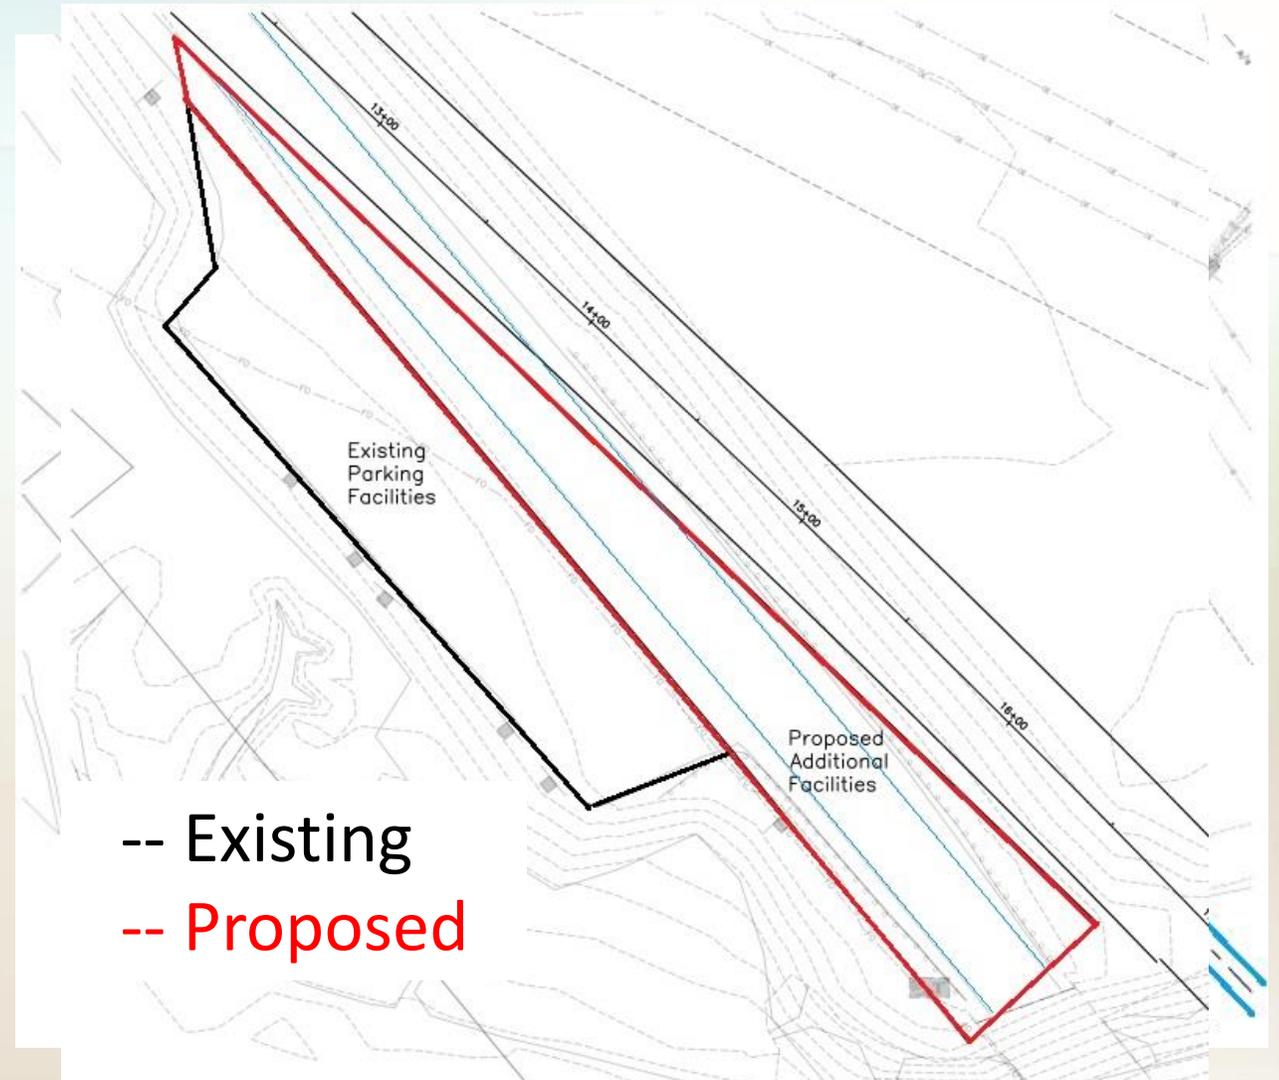
- Expand northern parking lot
- Accommodations for a future shared use path to cross under bridge
- Connection to shared use path on bridge
- Safer access to southern parking lot
