Cooper Creek Bridge

2019.03-Project Review
UAA Civil Engineering Capstone

NOMAD ENGINEERING

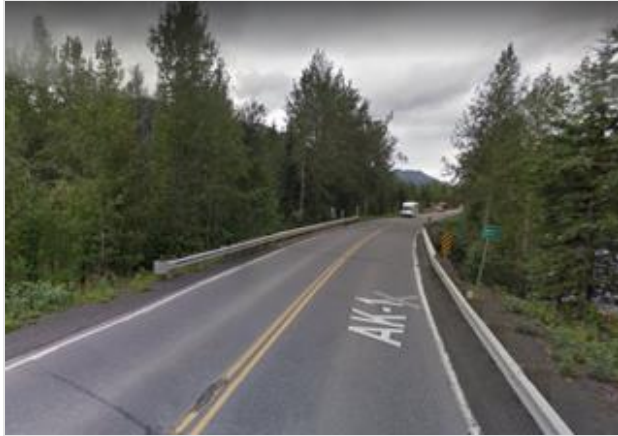
Unsafe Travel Conditions

- Non-existent shoulders
- Narrow and tight curves
- No space for pedestrians to cross bridge

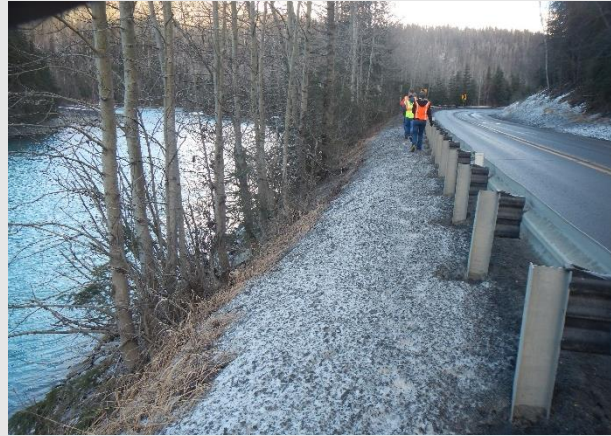
Lack of Connectivity

- No paths for pedestrians and bikers
- Unsafe conditions
- Discourages active modes of travel

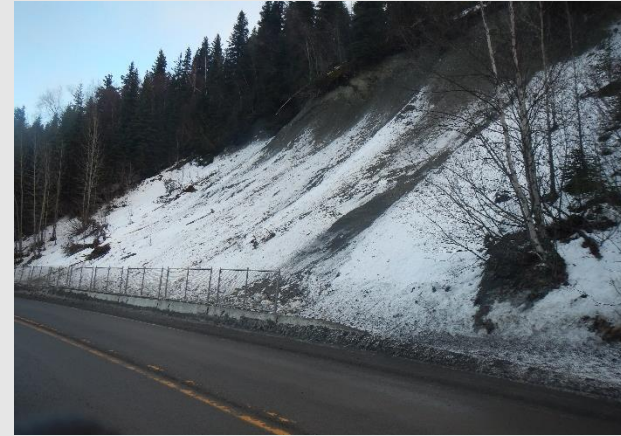
Environmental Constraints

- Unstable and steep backslopes
- Silty soils
- Anadromous stream habitat

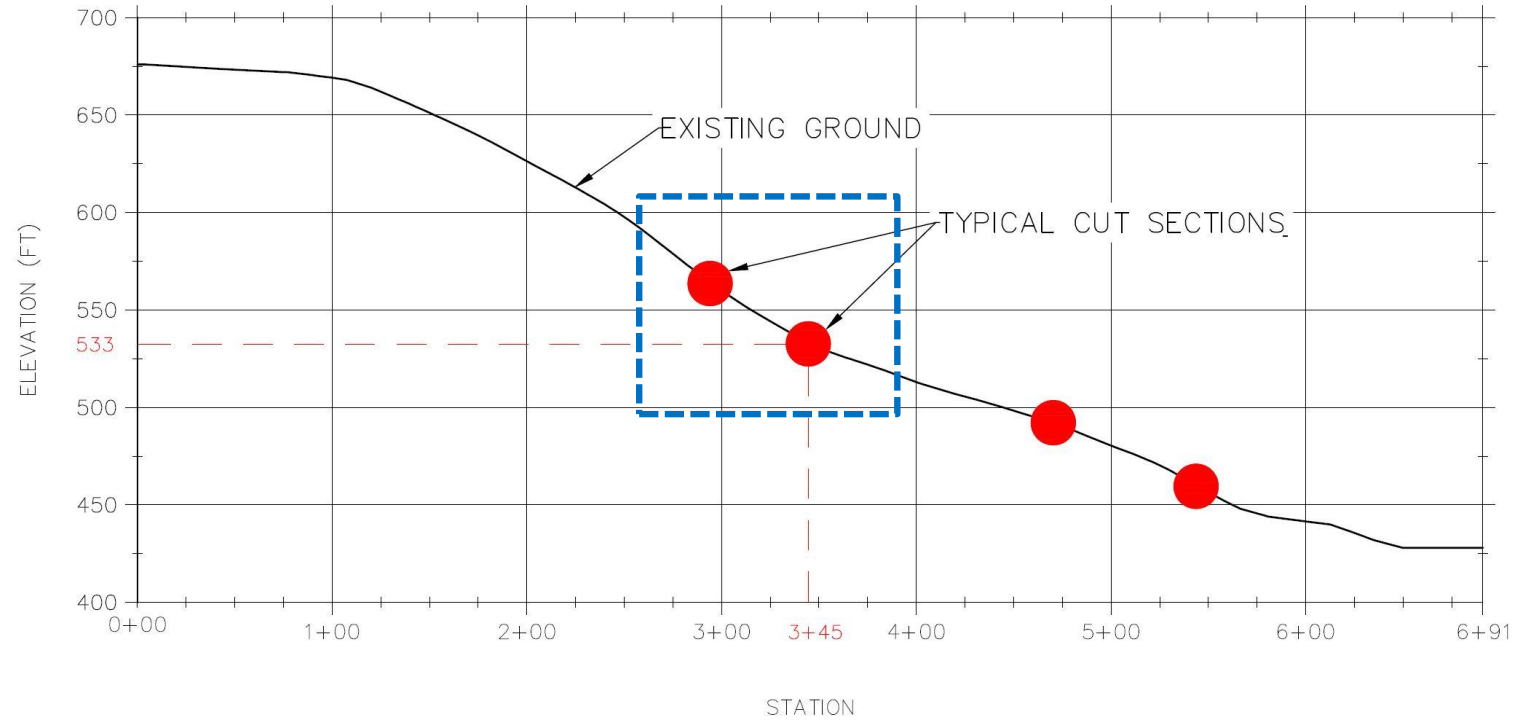
SECTION VIEW

ALTERNATIVE 3

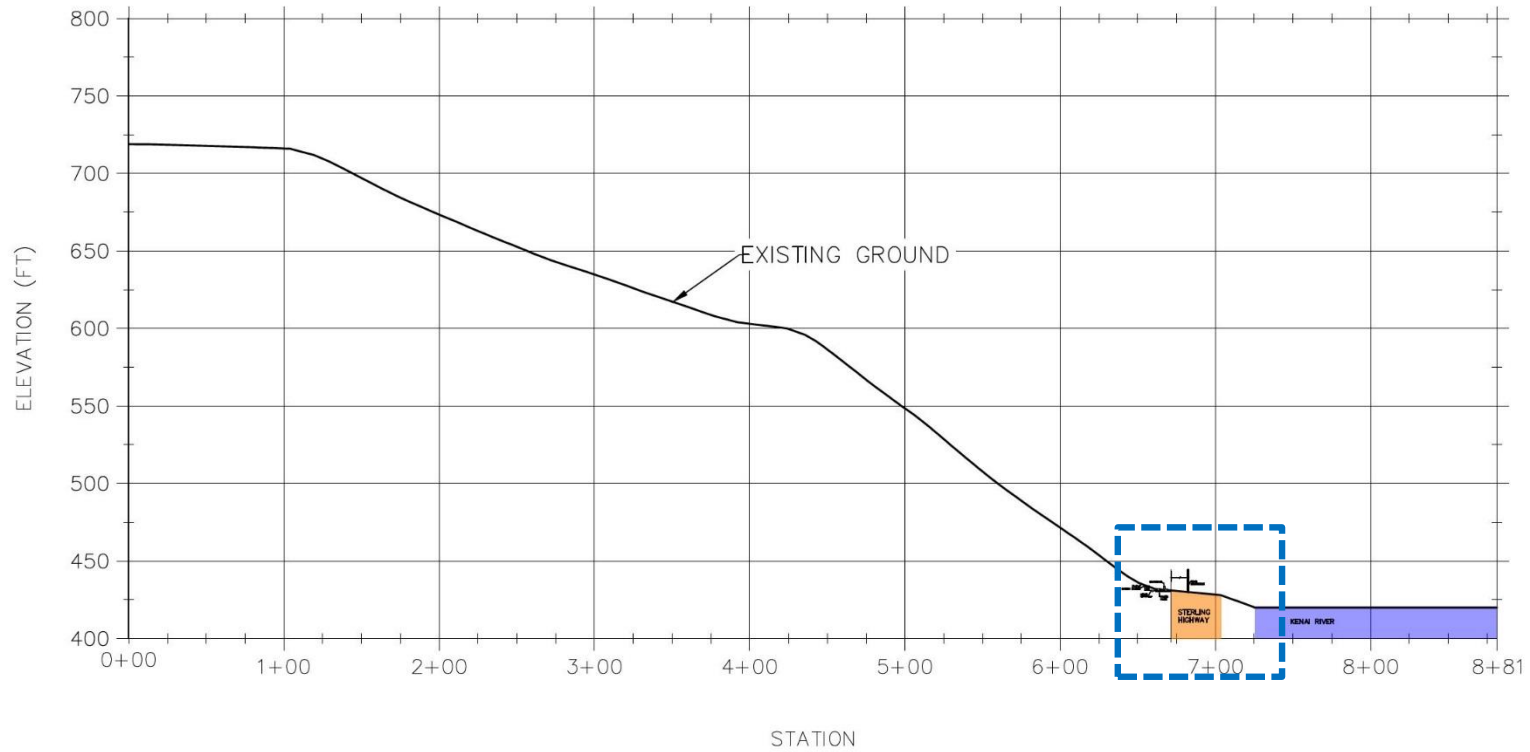
SECTION VIEW

ALTERNATIVE 2

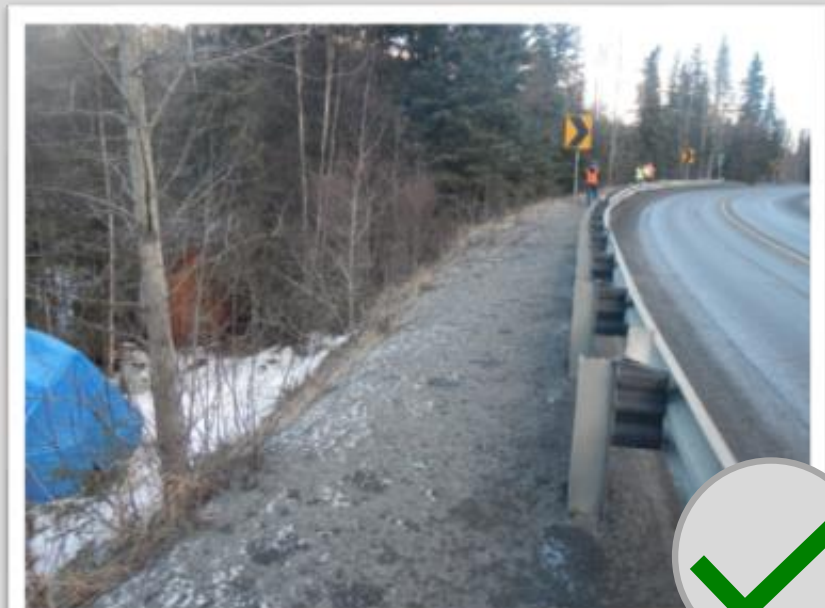
- Meets 5' min clear width requirement
- Compacted and level ground
- Clear of vegetation

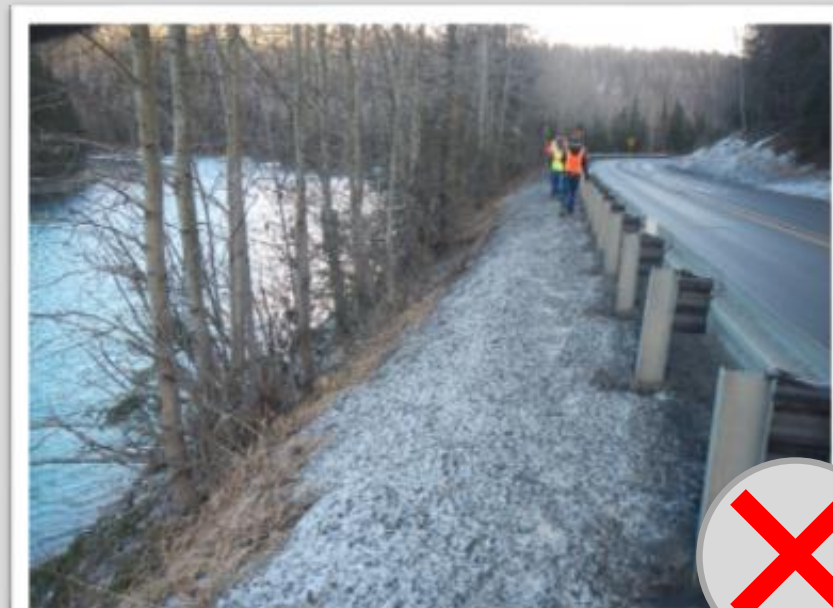
- Insufficient tread width for travelers
- Uneven and unstable ground
- Vegetation growth during the summer

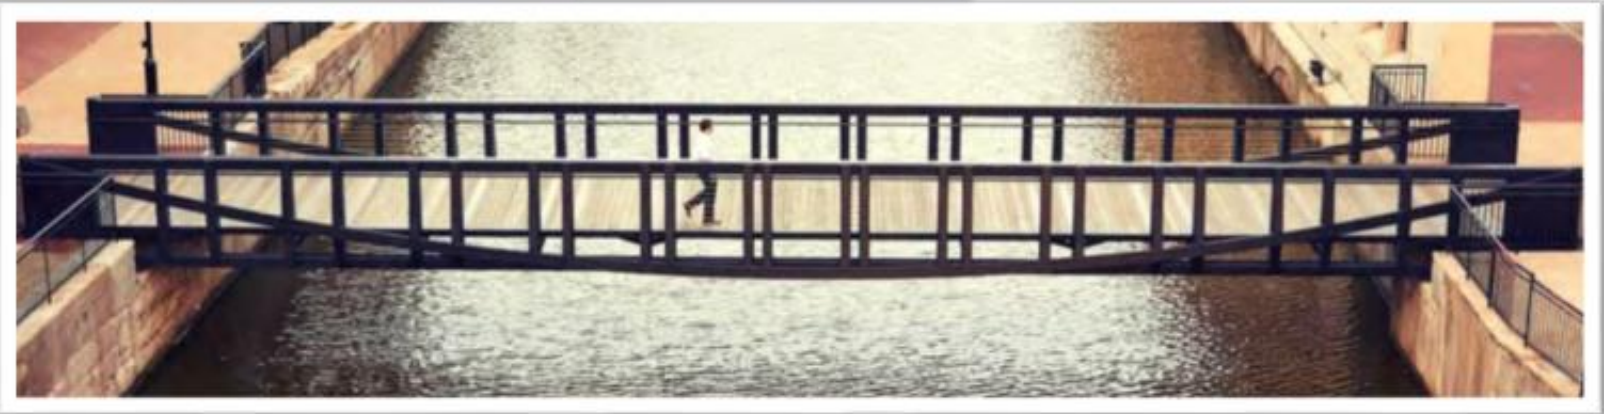
*Images taken from Bridge Brothers' product pamphlet
