APRIL 2017

# Design Study Report

PEDESTRIAN BRIDGE INSPECTION  
MOA PROJECT B

Samantha Caldwell  
Shelley Giraldo, P.M.  
Jared Kinney  
Brian Weigand  
SEAWOLF ENGINEERING

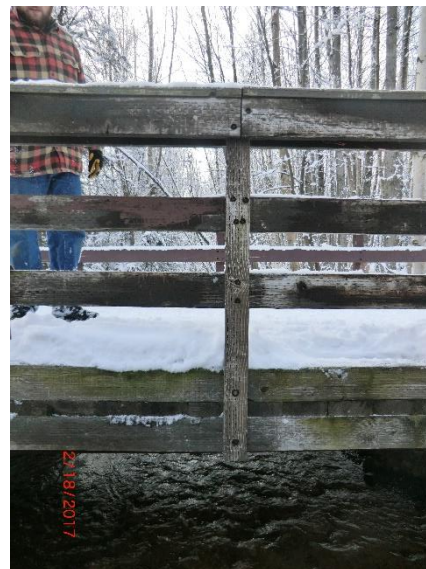
Figure 2: Timber Frame

The Tikishla Park Bridge North spans approximately 30' across Chester Creek. The simply supported pedestrian bridge has a pressure treated timber frame and decking which rests on a (2) 2x8 spacers connected to (2) W10x33 steel girders by 1/2" steel bolts spaced 3' O.C. (on center). The bridge decking is framed (top and bottom) between 6x6 timbers, as depicted in Figure 2. A wooden railing system is attached to the outside face of the timbers with railing posts at 5' O.C. The two steel girders are symmetrically placed 17 7/16" O.C. from the edge of the decking and are spaced 6'-1 1/2" apart. The shallow foundation system is composed of the girders resting on the concrete abutment. Type II classified fill/backfill compacted to 95% was used for the bearing soil.

Site visits suggest that no rehabilitation of the bridge has occurred since its construction. Original plan drawings were completed in 1985 as part of Schedule B of the Chester Creek Greenbelt Development project. MOA was only able to provide 2 out of 16 sheets (sheets 6 and 15) of the plan set. There were no general notes, specifications, design codes, or design criteria provided on the obtained plan sheets. Additionally, no load limit was demarcated on the provided plan sheets, but there were callouts for installing bollards and signage stating "No Unauthorized Motor Vehicles." During the bridge inspection and multiple site visits, no load limit signs, bollards, or signage prohibiting unauthorized vehicles were observed.

the analysis results, Seawolf Engineers recommends that Parks and Recreations posts signage, places bollards, or rehabilitates/replaces the bridge (see Appendix D).

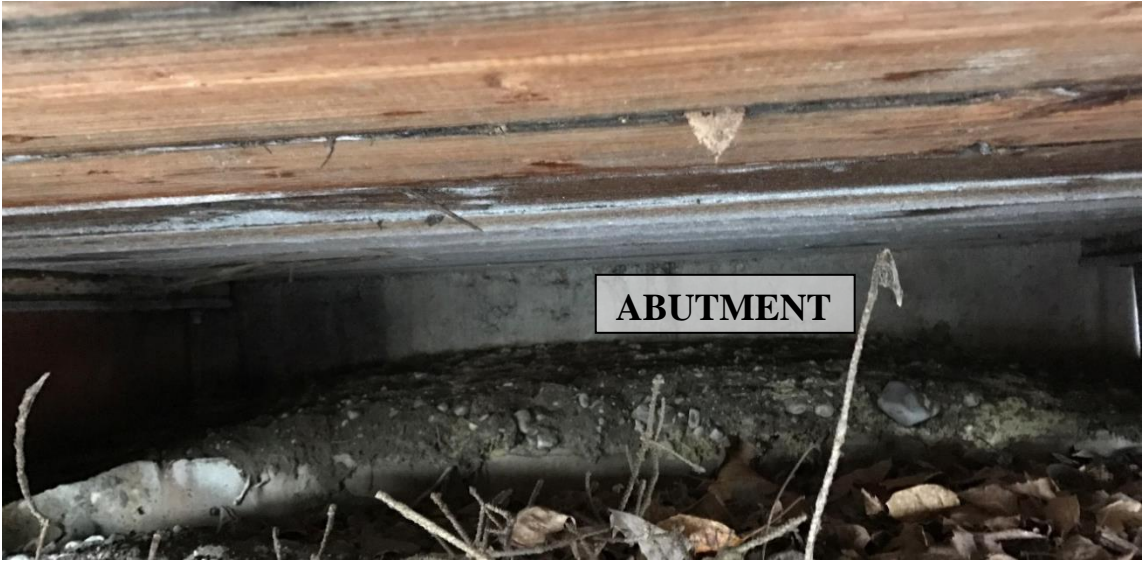
Figure 17. Limited Crawlspace

Abutments may be difficult to inspect if they are buried or if there is not enough crawl space under the bridge to allow access. The Tikishla Park Bridge North on the Chester Creek Trail in Anchorage has abutments that are very difficult to inspect, as depicted in Figure 17. In similar cases, the inspector should make his/her best effort to access the abutment while keeping safety in mind first.

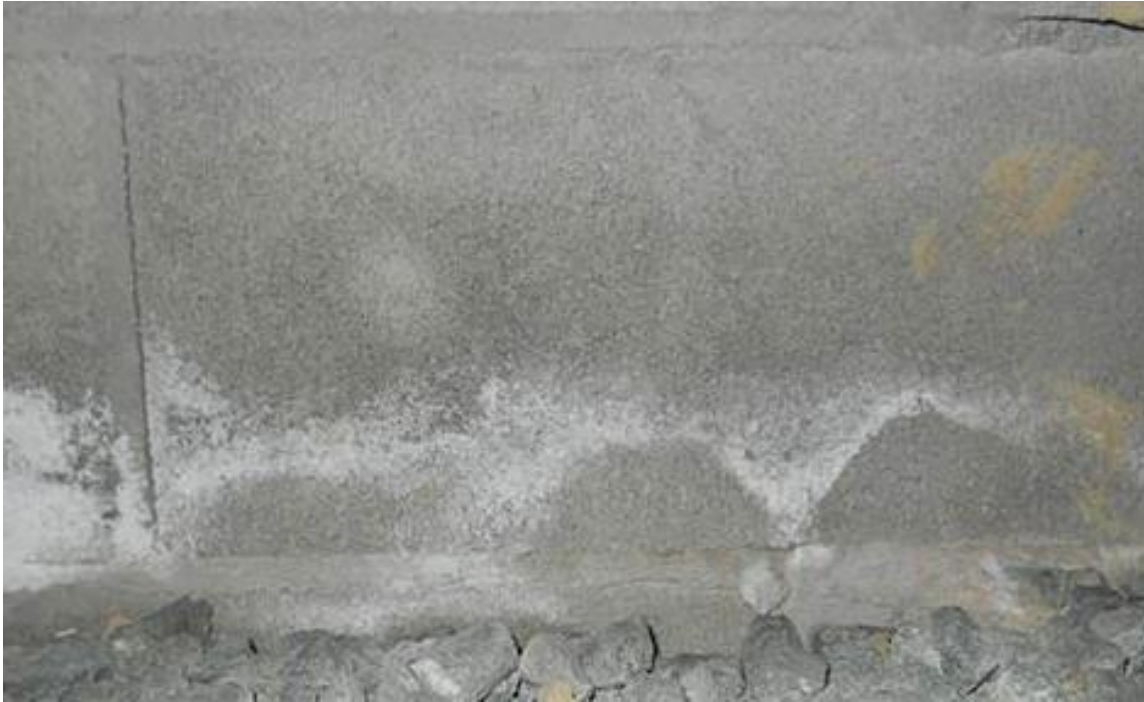
*Figure 21. Concrete Efflorescence*

When inspecting, each noted deficiency should be photographed. The inspection survey provides a “Condition” field that should be used to further specify and describe the condition of the component being assessed. For example, if horizontal cracks have been found in the abutment, the width and location of the cracks should be recorded. If members are not visible due to snow, ice, or soil, this should be noted. If there is efflorescence or moss on the concrete, the location and severity should be described. For example, “the concrete abutment exhibits localized efflorescence on the left side of Approach 1.” Efflorescence, or chloride contamination, occurs when salt migrates to the surface of the concrete, where it leaves a whitish stain, as shown in Figure 21.
