GROUP B – PEDESTRIAN BRIDGE INSPECTION PROJECT Final Presentation

Samantha Caldwell
Shelley Giraldo
Jared Kinney
Brian Weigand

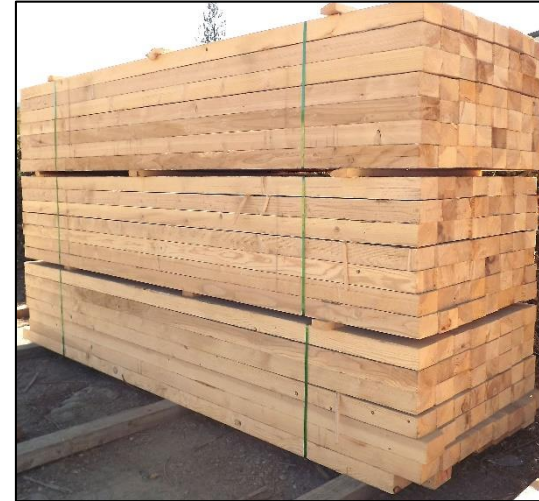
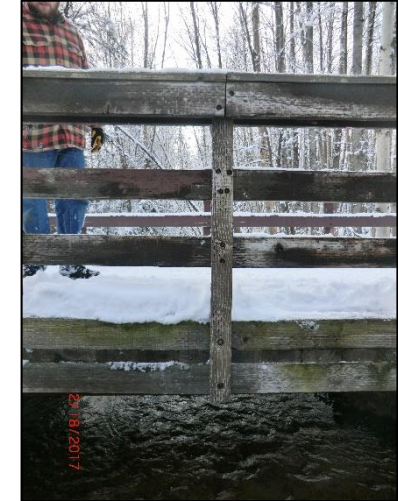
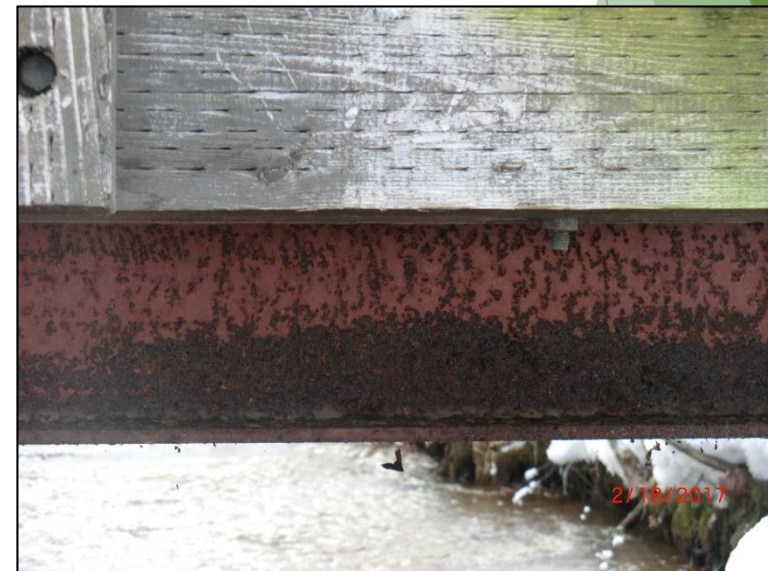
Structural Analysis Assumptions

- ▶ Tikishla Park Bridge North
- ▶ Spans 28.5' X 9' Wide
- ▶ Limited Sight Distance
- ▶ Wooden Railing and Deck
- ▶ Supported by (2) W10x33 beams

- ▶ Timber is Hem-Fir
 - ▶ 1/8 inch of decay on all surfaces
 - ▶ Decking is commercial grade
- ▶ A992 steel
 - ▶ Negligible section loss
 - ▶ Decking does not provide bracing for girders
- ▶ Tire contact area is 10"X20"
 - ▶ 3 planks engaged

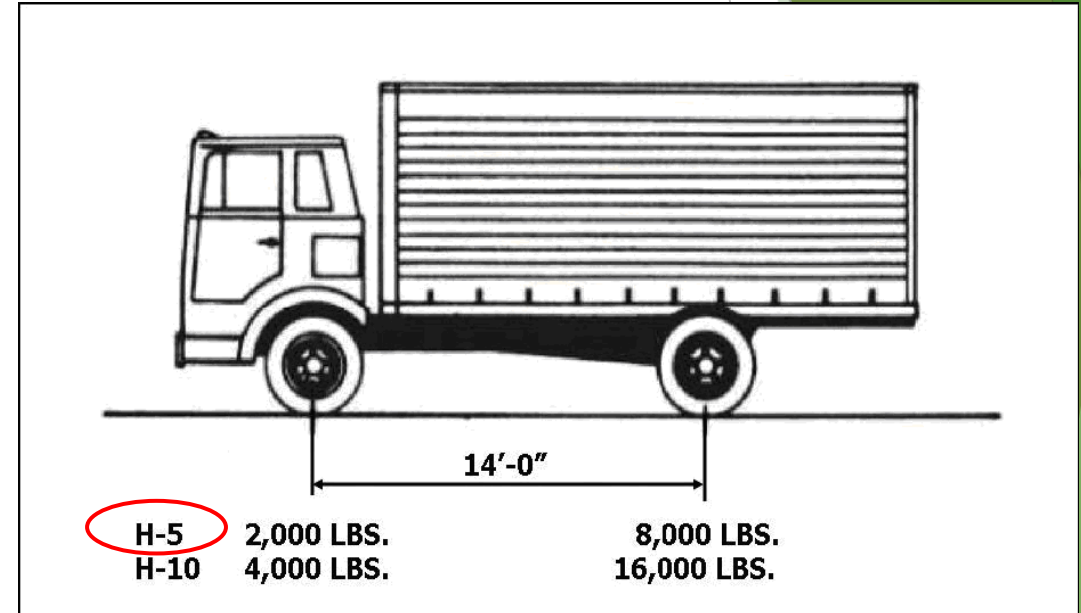
Design Vehicle: H-5

- ▶ Live (Pedestrian)+Dead+Snow Loads
 - ▶ Pedestrian - 90 psf
 - ▶ Dead (Self-Weight) - 4500 lb
 - ▶ Snow - 42 psf
- ▶ Dead+Live (Vehicle) Loads
 - ▶ Dead (Self-Weight) - 4500 lb
 - ▶ Live (Moving Vehicle Load)
 - ▶ Front Tire - 1 kip
 - ▶ Back Tire - 4 kip

- ▶ Timber Decking
 - ▶ L+D+S: did not fail
 - ▶ D+L: failed due to shear
- ▶ Steel Girders
 - ▶ L+D+S: failed in bending (and deflection)
 - ▶ Pedestrian Load: 152 people (not likely)
 - ▶ D+L: did not fail (excessive deflection)

- ▶ Install removable bollards
- ▶ Provide signage preventing unauthorized vehicles from crossing
- ▶ Rehabilitation/replacement of railing
- ▶ If decking is going to be replaced, entire timber frame should be replaced
- ▶ Replace bridge
