# CE A438 Design of Civil Engineering Systems

## Forest Park Condominiums

***Tectonic Engineering:***

# PROJECT SUMMARY

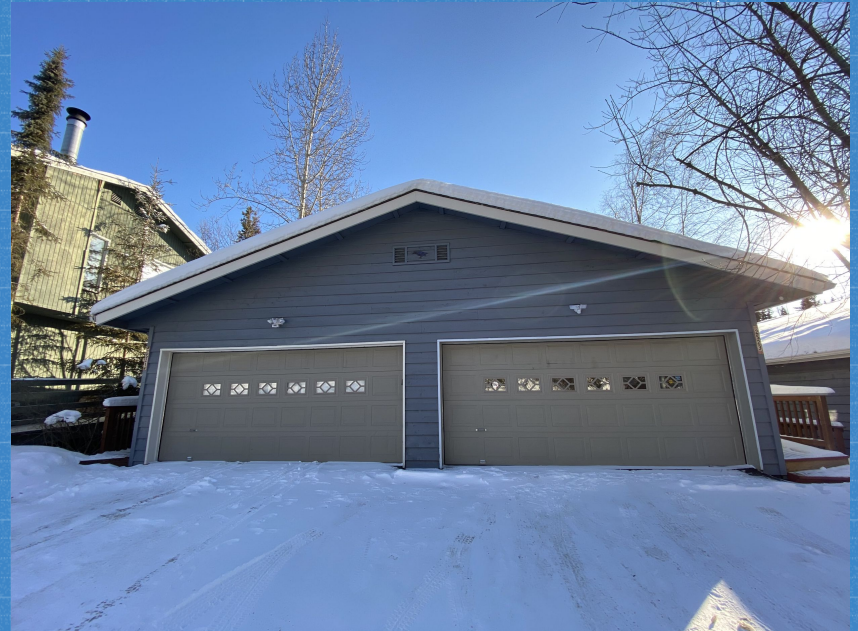
- November 2018 Earthquake
  - Foundation wall
  - Inadequate bracing
  - Minimal Shear Strength
- Scope of Work
  - Review existing
  - Create model
  - Develop Alternatives

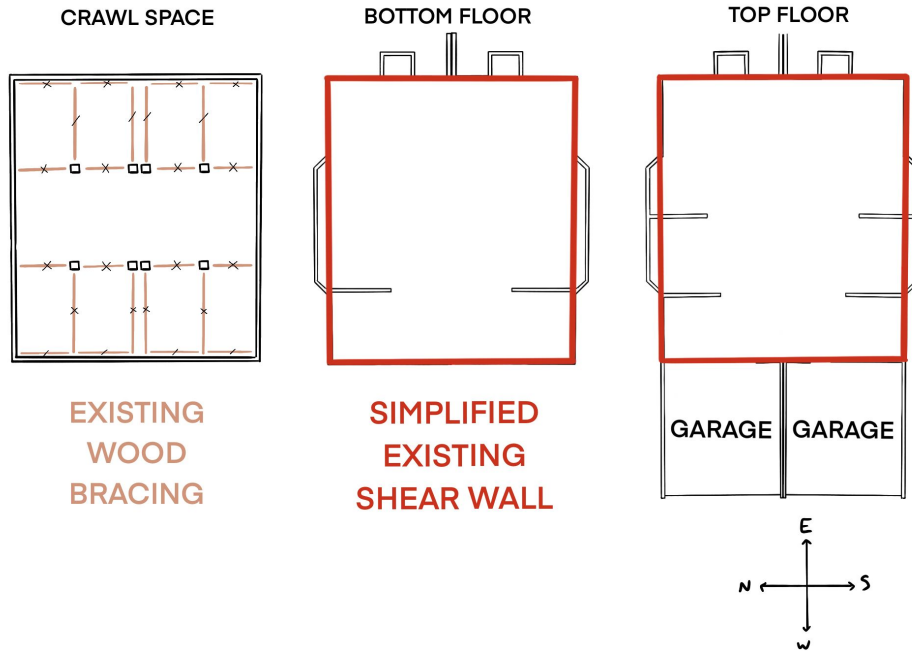
# BASIC STRUCTURE - LATERAL

- Attic trusses
- Minimal shear walls
- Wood bracing in crawl space
- Wood piles on concrete footers

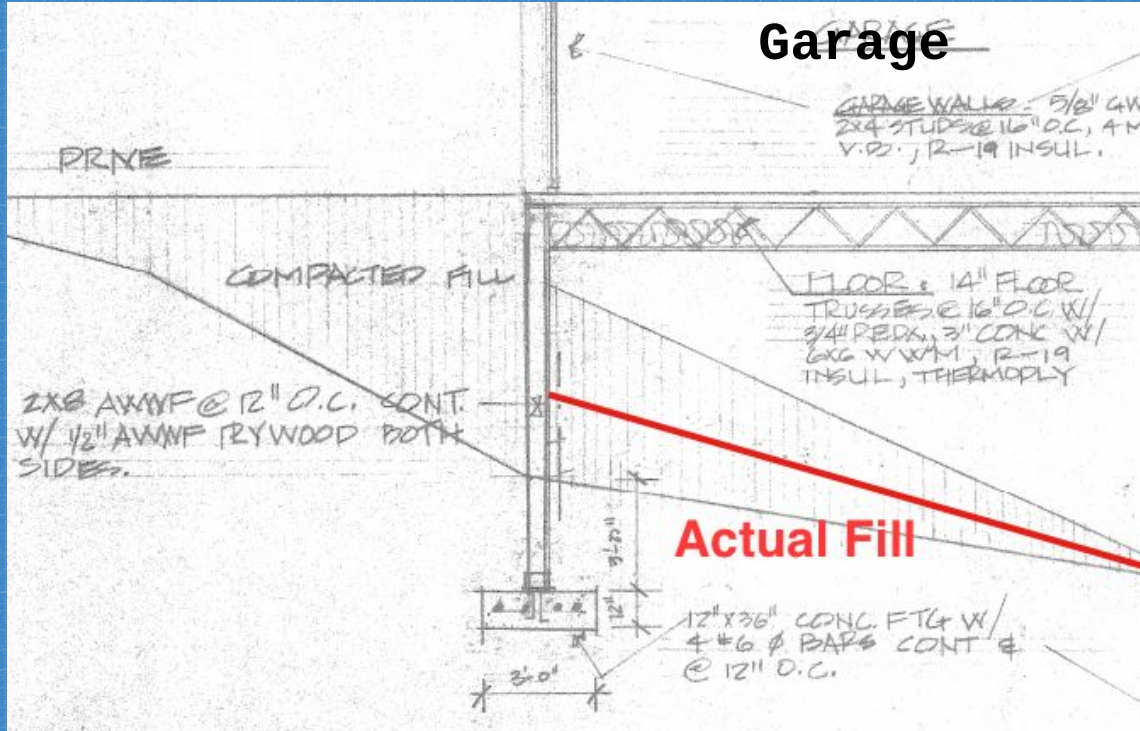
# BASIC STRUCTURE - GARAGE

Longitudinal trusses

Foundation wall

Compacted fill

Wood piles on concrete footers
