UAA Senior Design Project

Design Study Report ARRC Yard Rehab - Water

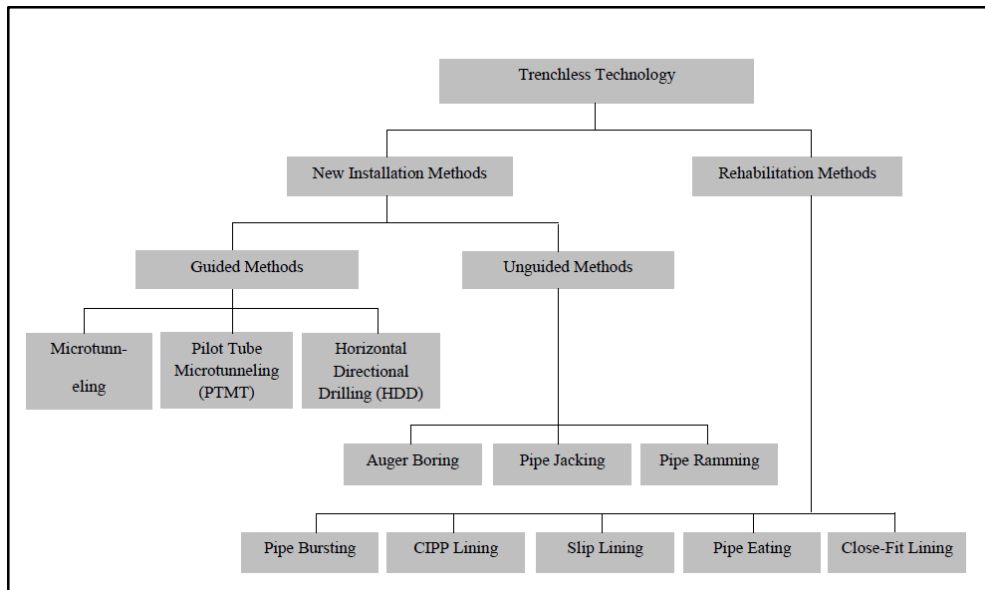
Figure 2: Family of Trenchless Technologies (Gottipati)

There are two main categories for trenchless techniques, trenchless construction and trenchless rehabilitation. Construction involves the installation of new infrastructure using techniques that drill, ram or ream a pipe into place. Rehabilitation involves techniques that repair or replace existing infrastructure. Under these two categories of trenchless technology there are numerous methods. Figure 2 lists the most common techniques.

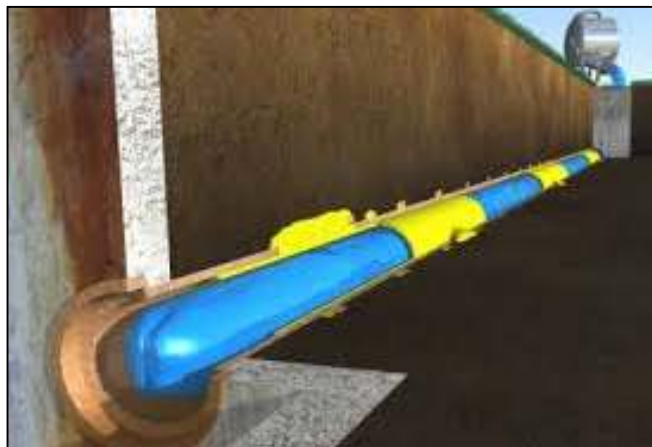
Figure 5 - CIPP Installation

then placed at the entrance of the pipe and is usually inverted before installation. There are two common methods for installing the liner. Either water or air is pumped into the liner at the entrance of the pipe. The inverted liner will roll itself down the pipe flipping the right-side out to meet the surface of the old pipe. Once the liner is in place one of two methods is used to cure it. One method is to

use hot water to cure the new liner. The second method is to use an infrared snake device

to move through the liner and cure it from the inside.

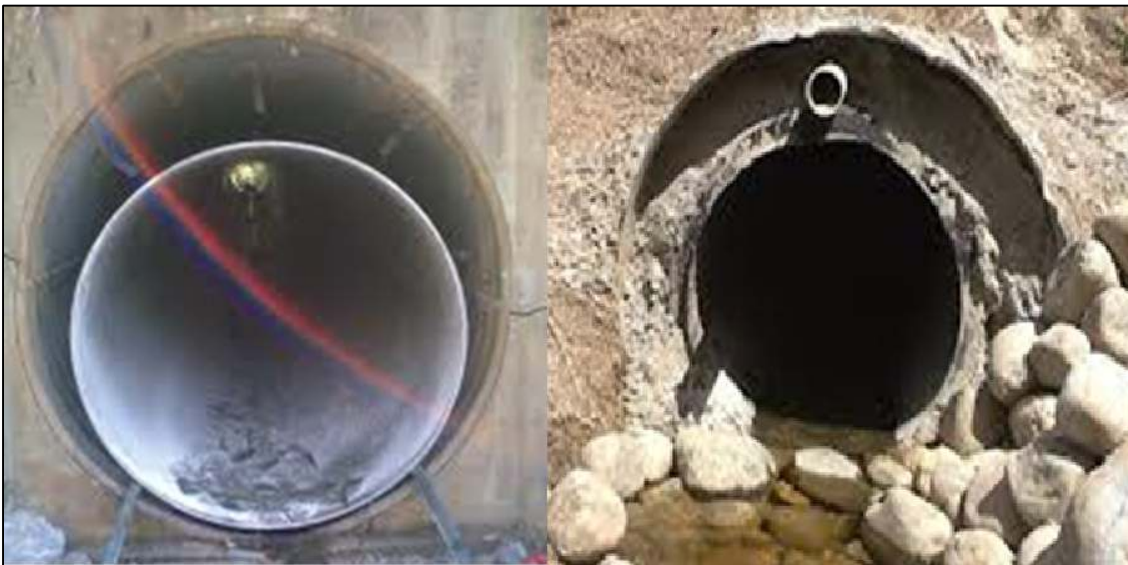
Figure 6: Slip lining – before (L) and after (R)

Slip lining is another rehabilitation method. It is similar to CIPP in that it lines the inside of an existing pipe. Instead of using a woven liner, slip lining uses a smaller pipe to slide into the existing pipe. Each side of pipe is enclosed, and a grout with the consistency of water is pumped

between the liner and the old pipe to seal any gaps and hold the liner in place.

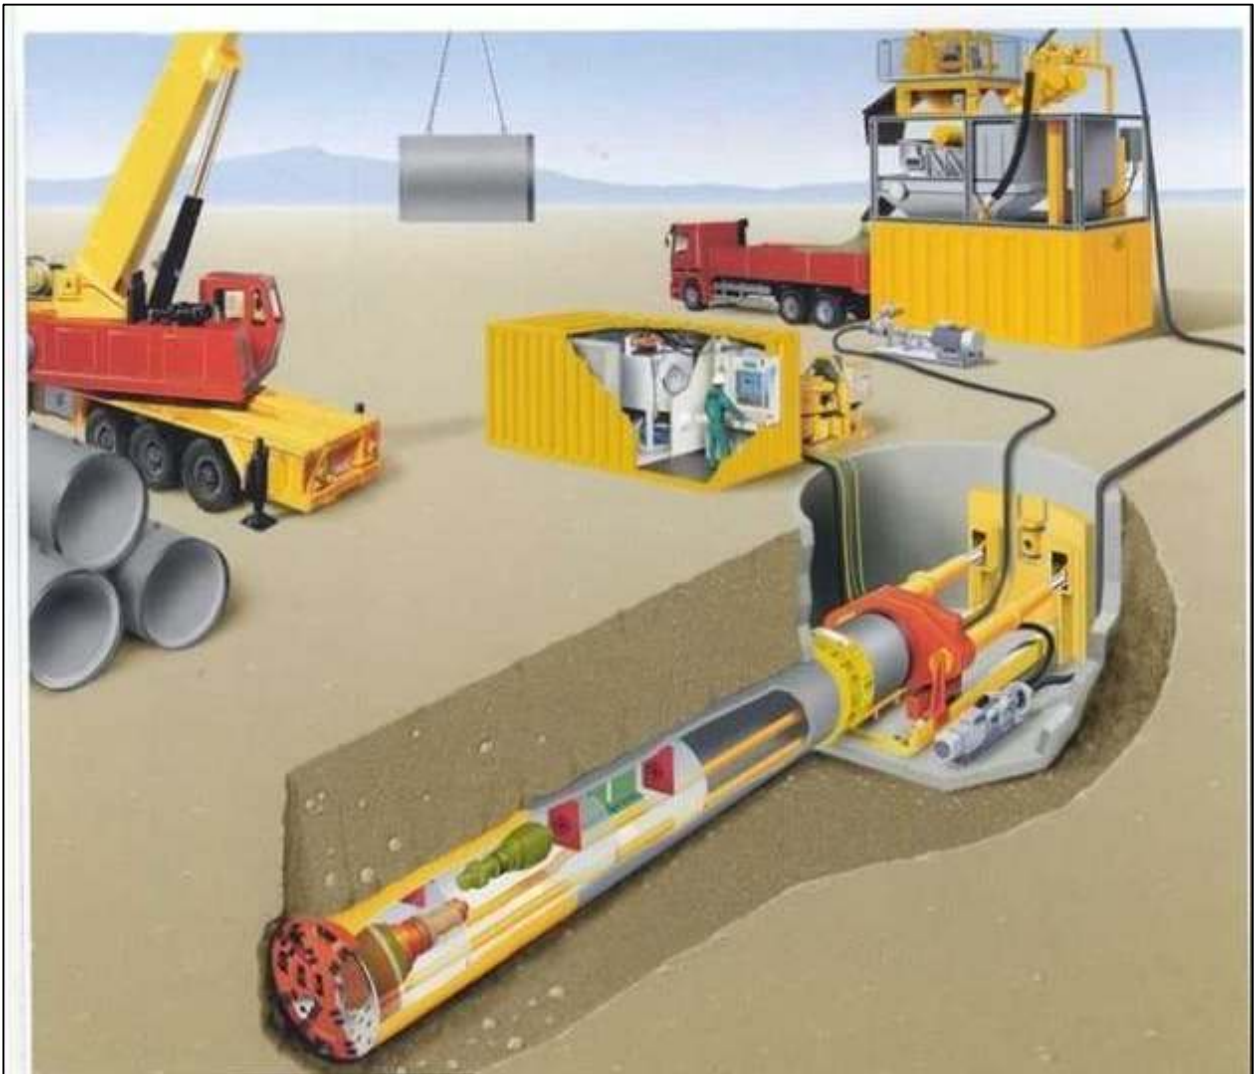
Figure 10: Micro Tunneling

Micro Tunneling is a new pipe construction method that is similar to auger boring, however the primary difference is that a lubricate solution is used on the drill bit to produce a slurry out of the tailings. The slurry is pumped out of the excavated pit into a holding tank. Micro tunneling is highly steerable and is used for large diameter pipes. Due to the fact the micro tunneling is mainly used for large diameter sewer pipes, it is less applicable to this project. Micro tunneling is not generally done in Alaska and

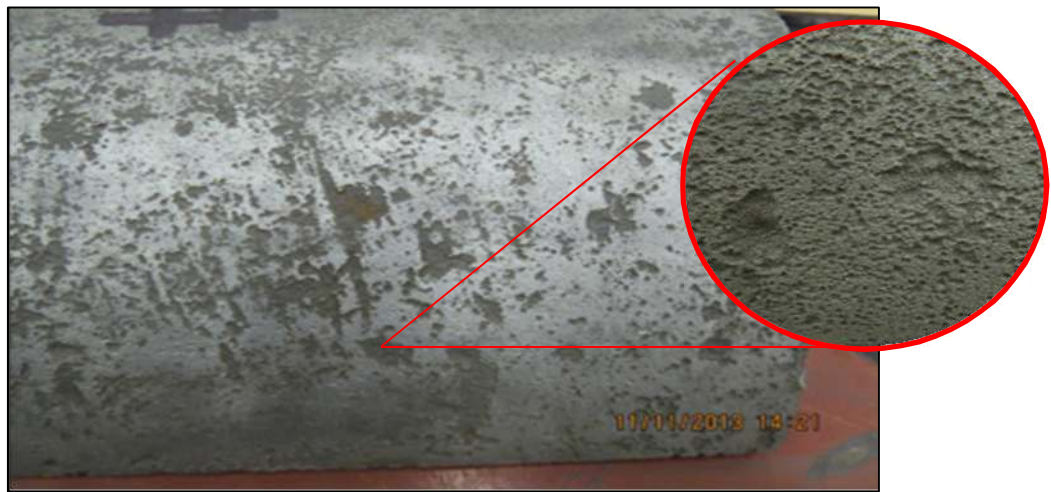
Figure 11 – Condition of Similar Pipe (UAA Corrosion Lab)

Installation of the pipe was in the 1940's and 1950's and used cast iron (gray iron). *Figure 11* show examples of a similar pipe near the project location that was also

installed during the same time frame. Pit depth in the outer diameter of the walls reached depths of over 0.14 inches with an average depth of about 0.1 inches. These pit depths are spurred from the obvious corrosion taking place. With thinner walls comes more potential for a failure of the water line.

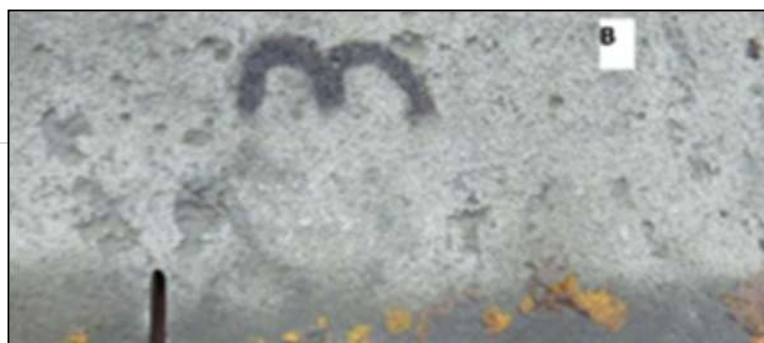
As seen in Figure 12, corrosion in the form of tuberculation is creating substantial pit depths on the inner diameter walls. UAA's Corrosion Lab has stated these depths to be on the magnitudes of 0.26 inches with an average pit depth of 0.193 inches when comparing multiple pipes from the area. These depths of corrosion, teamed with the corrosion from

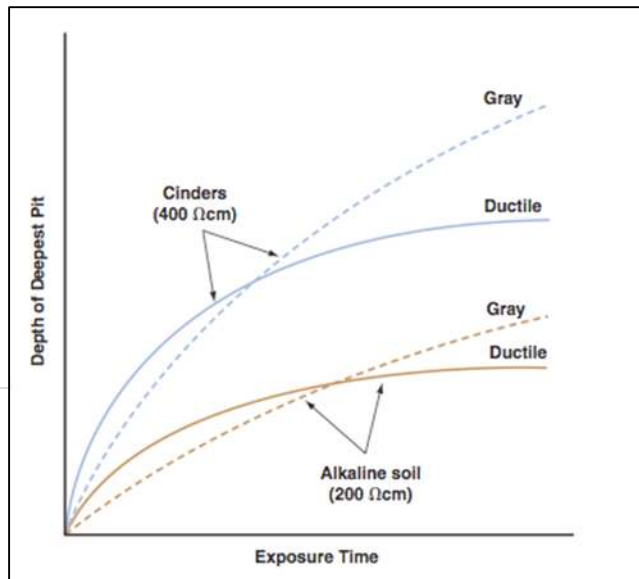
[Figure 13 - Ductile Iron vs. Cast Iron in Corrosive Soils](#)

Not only does Ductile Iron outperform Gray Iron in break rates, but it also outperforms in terms of corrosive protection. Figure 13 shows a plot of outer diameter pit depth (due to corrosion) for Ductile Iron vs. Gray Iron in two different types of soils. This study was done without usage of any corrosion protection mechanism. After reviewing these results, only PVC and Ductile Iron Pipe were further considered for use on this project.

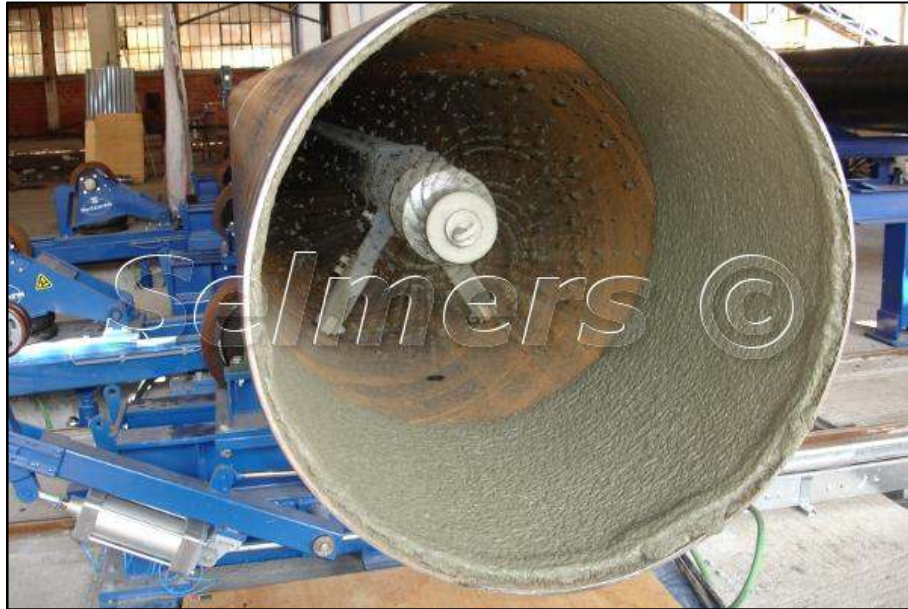
Figure 14 - Interior Cement Lining Depiction

Significant contrast between PVC and Ductile Iron is associated with the cost of corrosion protection for each material. To protect Ductile Iron, the methods researched for this project consisted of using an interior cement lining and exterior wall protection

such as cathodic protection, polyethylene wrapping and polyurethane coatings. *Figure 15* depicts the application of an interior cement lining. Using an interior cement lining has shown that it does not increase friction losses when water flows through the pipe. The Hazen-Williams flow coefficient actually remains around 140 (ductile iron piping has a Hazen-Williams flow coefficient of 140). The lower the flow coefficient number, the higher the flow loss due to friction (as comparison, Cast Iron has a flow coefficient between 113-83).

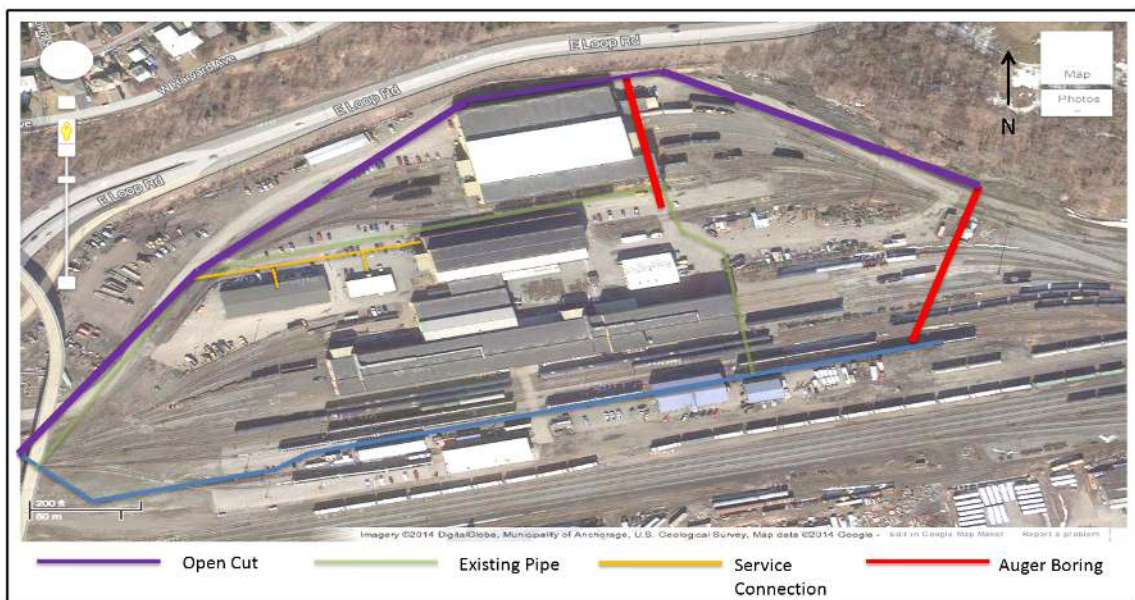
Alternative 2 proposed alignment has the 10” transmission line starting at the south west corner of the rail yard, and loops around the fueling and maintenance building, passing underneath the section of track in the south-east corner of the yard. This design uses open trenching for 2400 LF of pipe, and trenchless auger boring techniques for 350 LF of pipe placement underneath tracks and service connections to the surrounding buildings.

The alignment was designed as a redundant loop connecting to the main water transmission line at two points, while placing the longest section of the pipe network away from the buildings and from underneath the largest grouping of railway tracks.

Using flow analysis from AWWU’s planning department, modeling showed that the required fire flow of 5000 GPM at 20psi was met for this design. Comparison of this alternative, using the criteria developed by the Seawolf Engineering group, shows that this design met all criteria with an estimated cost of \$5.75 million dollars for design and construction. Alternative 2 was chosen as the recommended design to proceed with further investigation for construction.

The alternative route alignment recommended by this study is the “Big Loop” 10-inch diameter transmission line that loops around the maintenance and fueling yard, passing underneath the section of track in the south-east corner of the yard. This alternative was evaluated and chosen, using the criteria developed by the Seawolf Engineering group, which included: ease of maintenance, reliability, safety, minimize impact to services, and cost.

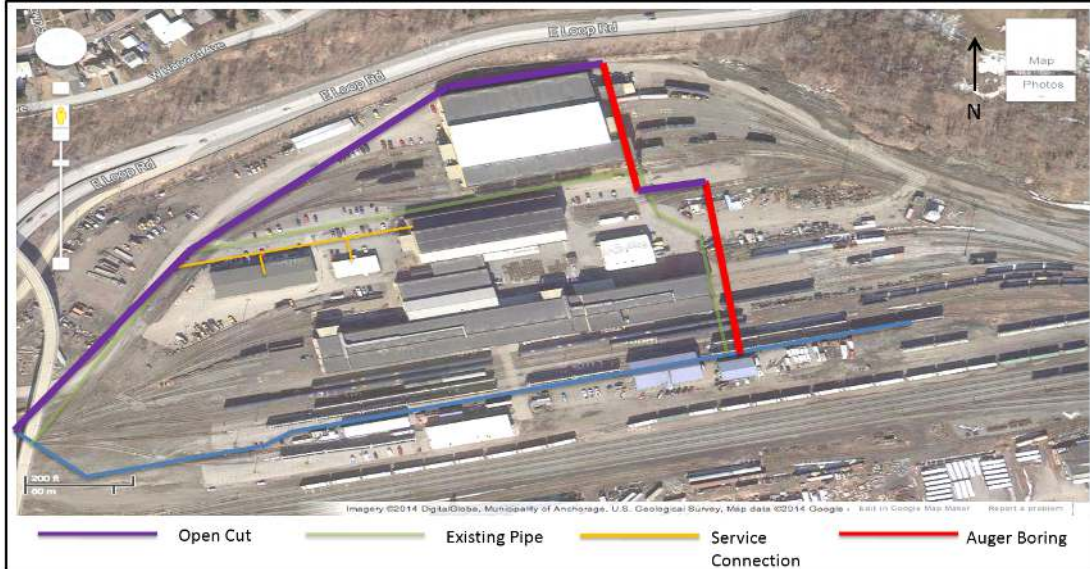
14.1.3 Alternative 3 – Small Loop

This alternative was considered a smaller version of the “Big Loop” alternative stated previously. This alternative was considered to investigate the potential benefits of using less open cut and more trenchless technology to place the pipe. This alternative requires 1676 feet of open cut (*the 2nd most of any alternative*) and about 770 feet of auger boring (*3rd most of any alternative*). However, the cost of using a higher amount of trenchless technology than the “Big Loop” alternative raised the cost to \$5.72 million, making it the second most expensive alternative investigated for this project.

Complications also arise when investigating the construction constraints associated with this alternative. Placing the pits in the necessary locations to use auger boring will adversely affect the operations of the railroad. Additionally, when connecting the proposed 10” line to the 16” main, there is insufficient space for a proper trenchless pit to be dug in the area. For these reasons, Alternative 3 was no longer considered.

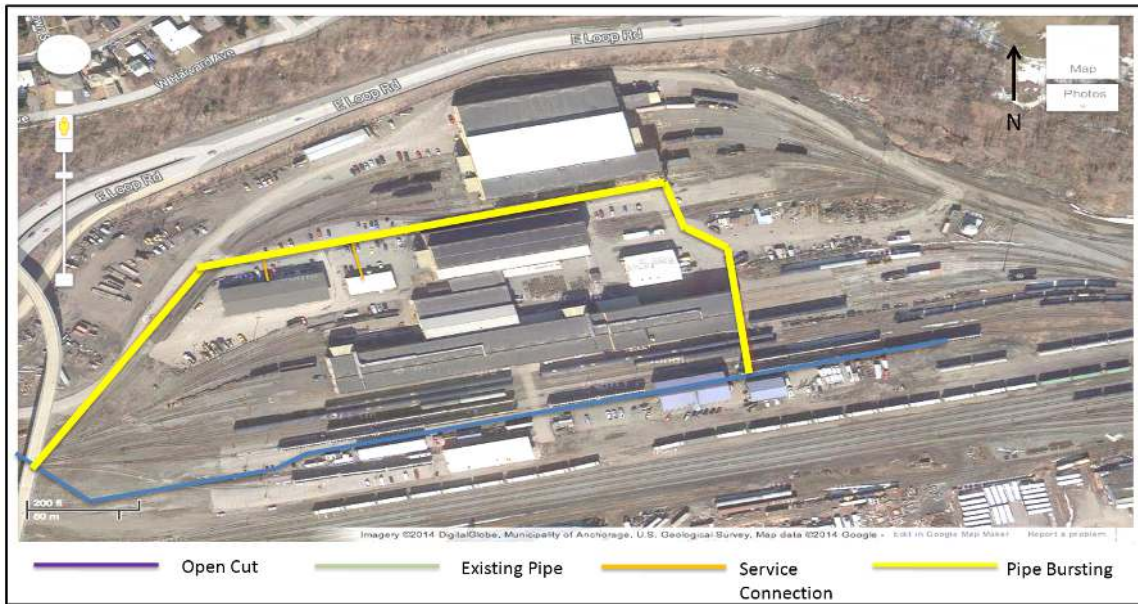
14.1.4 Alternative 4 – Pipe Bursting

Pipe Bursting has a proposed design that remediates the existing alignment using trenchless pipe bursting techniques. Placement of a new 10” PCV water line will be pulled into the alignment behind the bursting equipment. The entire 2000 LF water transmission line and service connections will remain in the current position.

This design continues to use a loop, connected at two points along the main water line giving flow redundancy for fire protection. Alternative 4, with the current

pipe layout meets fire flow requirements of 5000 GPM at 20 psi as per AWWU water flow modeling.

While meeting the requirements of fire protection, as well as having the lowest estimated cost of construction at \$4.10 million, the design did not address the initial problem of difficult maintenance, and disruption of service to the railroad during repair or construction of the water line. Due to not meeting this criteria, alternative 4 was eliminated from further consideration as a possible recommendation.

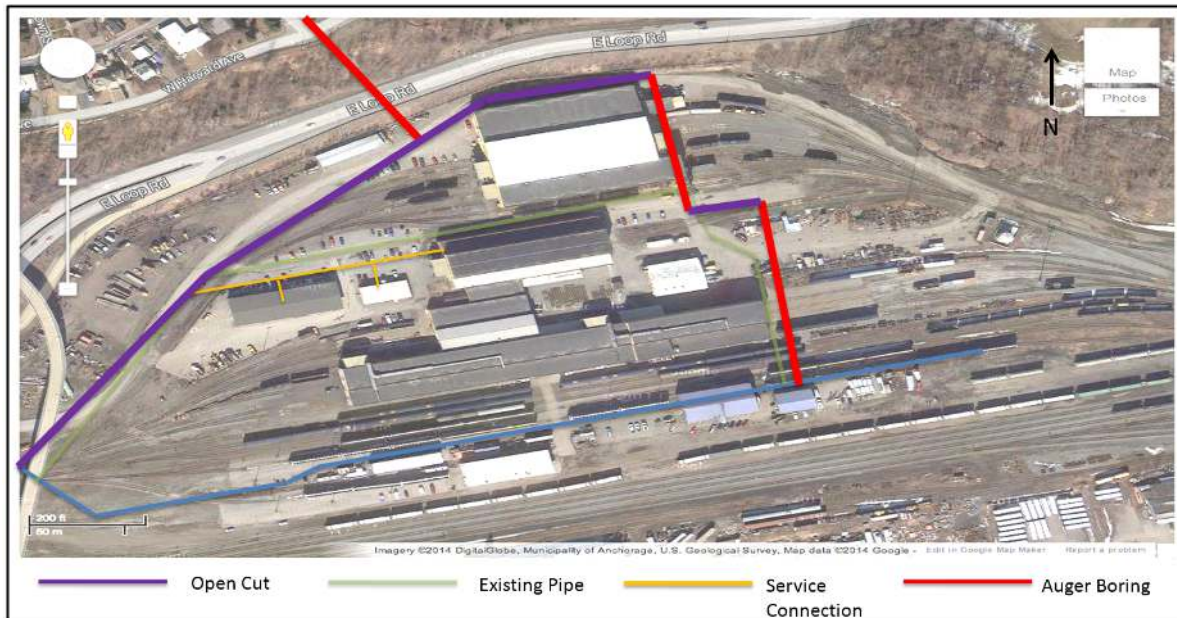
yard it would be causing unnecessary disturbance to the railroad yard's normal activities. The amount of maintenance the Government Hill alternative would require would be much more than the Small Loop's amount, primarily due to the addition of this extra line.

Costs for this alternative is the highest of the five alternatives at a cost estimated to be \$6.18 million. The difference from Government Hill alternative and our chosen Big Loop

alternative is about \$0.50 million. The pros of the Big Loop alternative outweighed the justification to spend \$0.50 million to the project. Overall the Small Loop alternative was ranked higher than Government Hill alternative, but the Big Loop alternative was chosen over these alternatives. More in depth analysis would be required to justify connecting the two systems. As of this report it is determined that there is no need to connect the waterlines from railroad yard to Government Hill.
