## **Alternative Analysis**

# **Potter Marsh - Old Boardwalk Rebuild Project CED 2020.04**

Extron, LLC

**April 20, 2020**

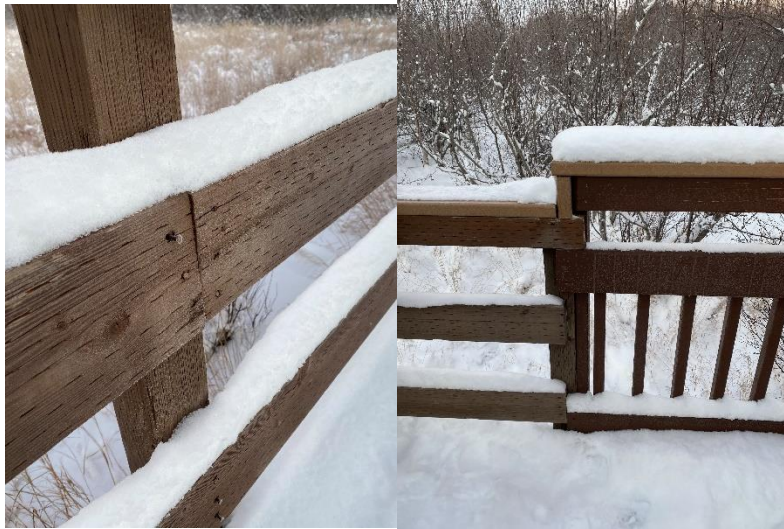
**FIGURE 2: EXISTING CONDITIONS**

Many of the problems with the boardwalk are visible such as loose railings, shifted joists, rot, and frostjacked piles. The boardwalk has exceeded its intended lifespan, does not meet all current codes and lacks certain design features that improve visitor experience. Some examples

of this are a lack of a distinct destination at the end of the boardwalk, as well as a lack of emphasized viewing areas that encourage visitors to linger in notable locations.

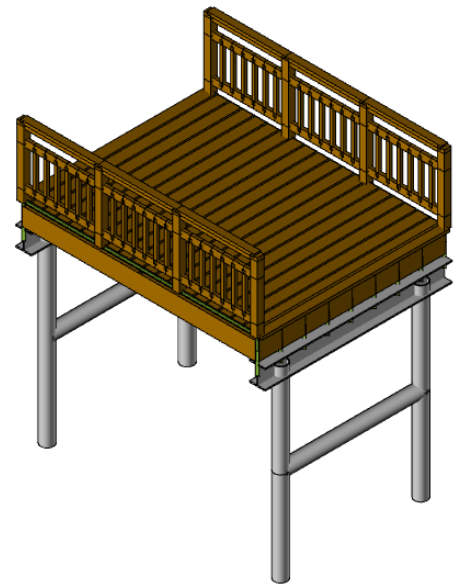
**FIGURE 6: BOARDWALK MODEL**

The boardwalk design represents a typical 10-foot section of boardwalk decking, including associated railing and piles, as seen above. Modular design for this boardwalk gives the client freedom to align the boardwalk to specific paths along the marsh as it guides visitors to critical areas where wildlife is more prominent. The boardwalk was also designed to have a maximum slope of 8% following the disability act. This allows the boardwalk to change in elevation to portray more dramatic experience as people walk along the path. The lower height of the boardwalk is designed as a deterrent for large animals like moose from wandering into the highway. Handrails were designed in accordance to the international building code in such a way that it is aesthetically pleasing, safe, and follows the guidelines. The boardwalk is designed to withstand the maximum live load, snow load, wind load and seismic load.

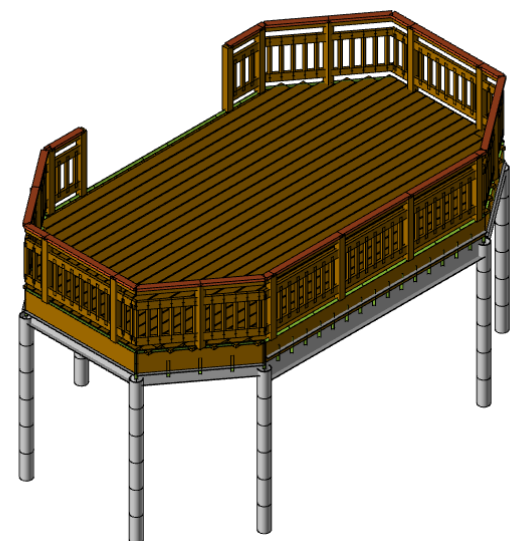
**FIGURE 7: VIEWING PLATFORM MODEL**

This represents the viewing decks that visitors would find at the end of the off shoots that can be found along the boardwalk route, including associated railings and piles as seen in Figure 7. The viewing platforms will have interpretive panels and scopes. It provides an area for visitors to stop, gaze at the wildlife and read information about them. This hexagon shape is chosen for aesthetic purposes. It mimics the 2018 boardwalk and creates a unified look.
